# Access Compliance Report

## Public Rights-of-Way

### (Curb Ramps)

Intersection ID: 29992	Main Street: REIGATE_RD	Cross Street: KEMPSFORD_DR	Location: S
ADA ID: BDE69EF98C0E	Ramp Type: PerpDiag	Initial Pass/Fail: Fail	Overall Compliance: No
Severity Score: 8.75			
Codes/Mitigation Info/Possible Solution		Field Measurements/Component Compliance

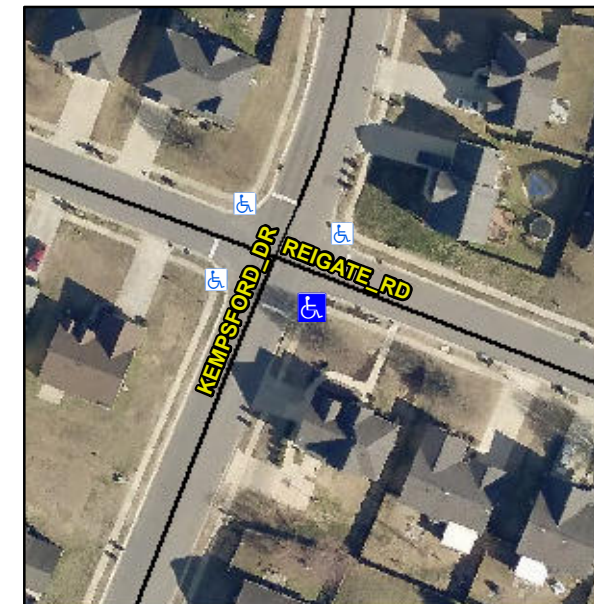
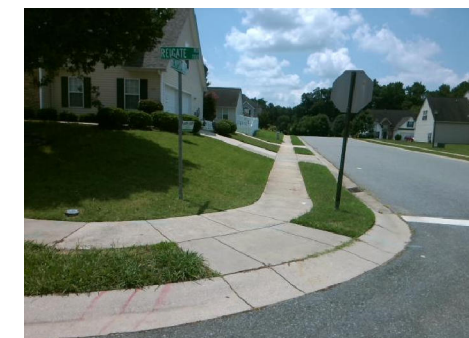
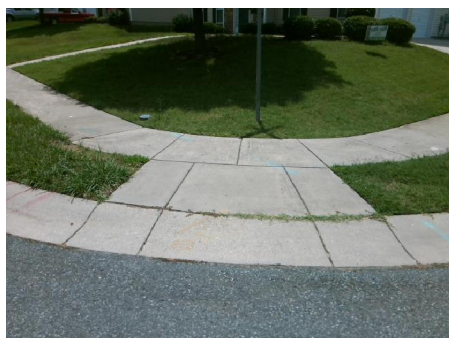
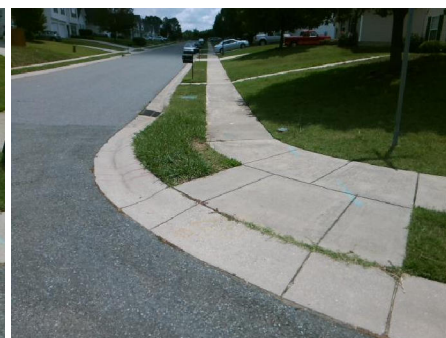
**Not Found, R304.5.1**

Compliance	Description	Data	Compliance	Description	Data
N/A	Ramp Length (in)	49.0	Yes	Ramp Slope (%)	5.0
No	Ramp Width (in)	43.0	Yes	Ramp XSlope (%)	0.9
N/A	Flare Type LT	N/A	N/A	Flare Type RT	N/A
N/A	Flare Slope LT (%)	N/A	N/A	Flare Slope RT (%)	N/A
N/A	Flare Traversable LT?	N/A	N/A	Flare Traversable RT?	N/A
N/A	Landing Length (in)	N/A	N/A	DWS Provided?	N/A
N/A	Landing Width (in)	N/A	N/A	DWS Contrast?	N/A
N/A	Landing Slope (%)	N/A	N/A	DWS Length (in)	N/A
N/A	Landing X Slope (%)	N/A	N/A	DWS Full Width?	N/A
N/A	Landing Curb? (Y/N)	N/A	N/A	DWS Offset (in)	N/A
N/A	Shared Landing?	N/A			
N/A	Gutter Ponding?	N/A	N/A	Gutter Slope (%)	N/A
N/A	Gutter Lip Ht (in)	N/A	N/A	Gutter X Slope (%)	N/A
N/A	Painted X Walk1?	No	N/A	Painted X Walk2?	No
	X Walk 1 Direction	To NE		X Walk 2 Direction	To NW
N/A	X Walk 1 Width (in)	N/A	N/A	X Walk 2 Width (in)	N/A
	X Walk 1 Slope (%)	0.7		X Walk 2 Slope (%)	1.6
	X Walk 1 X Slope (%)	1.1		X Walk 2 X Slope (%)	1.4

N/A	Ramp inside XWalk1?	N/A	N/A	Ramp inside XWalk2?	N/A
	Road Slope (%)	0.5	N/A	Clear Space?	N/A
	Road X Slope (%)	2.3	N/A	Clear Space to XWalk (in)	N/A
N/A	Any Obstructions?	N/A	N/A	Storm Grate/Utility Hazard?	N/A
	Obstruction Type			Storm Grate/Utility Type	
		N/A			N/A
			Yes	Surface Condition? (G/P)	Good

**Remove & Replace Curb Ramp With Two New Directional Ramps or Equivalent.**
