# Access Compliance Report

## Public Rights-of-Way

### (Curb Ramps)

Intersection ID: 10020967	Main Street: BENSEVAL_LN	Cross Street: N/A	Location: E
ADA ID: BDE8383875EB	Ramp Type: Perp	Initial Pass/Fail: Fail	Overall Compliance: No
Severity Score: 10			
Codes/Mitigation Info/Possible Solution		Field Measurements/Component Compliance

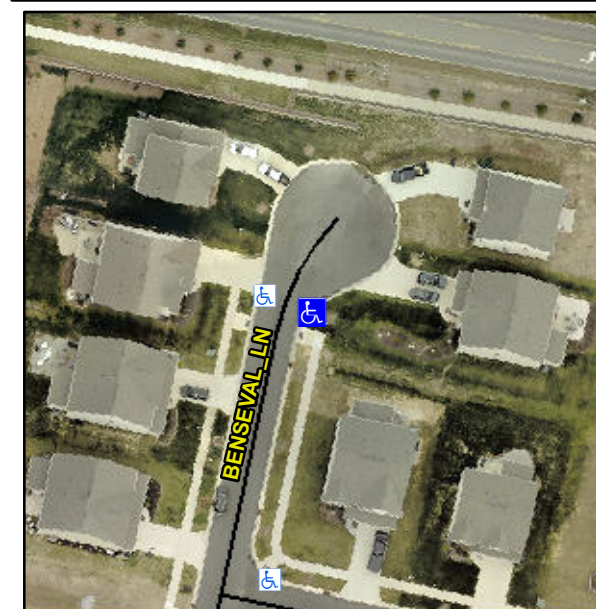
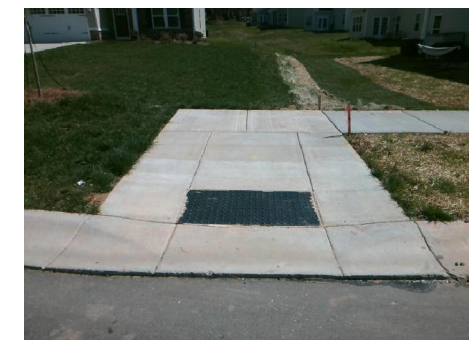
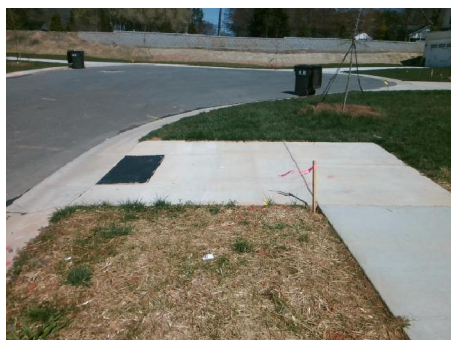
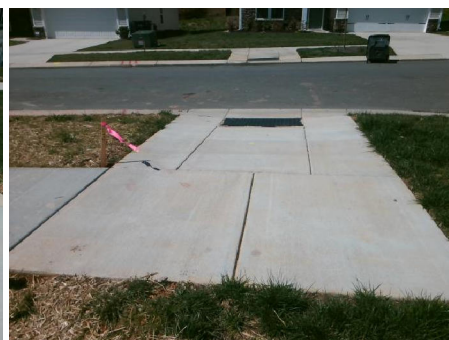
Compliance	Description	Data	Compliance	Description	Data
N/A	Ramp Length (in)	96.0	Yes	Ramp Slope (%)	6.8
No	Ramp Width (in)	47.5	Yes	Ramp XSlope (%)	2.6
N/A	Flare Type LT	N/A	N/A	Flare Type RT	N/A
N/A	Flare Slope LT (%)	N/A	N/A	Flare Slope RT (%)	N/A
N/A	Flare Traversable LT?	N/A	N/A	Flare Traversable RT?	N/A
N/A	Landing Length (in)	N/A	N/A	DWS Provided?	N/A
N/A	Landing Width (in)	N/A	N/A	DWS Contrast?	N/A
N/A	Landing Slope (%)	N/A	N/A	DWS Length (in)	N/A
N/A	Landing X Slope (%)	N/A	N/A	DWS Full Width?	N/A
N/A	Landing Curb? (Y/N)	N/A	N/A	DWS Offset (in)	N/A
N/A	Shared Landing?	N/A			
N/A	Gutter Ponding?	N/A	N/A	Gutter Slope (%)	N/A
N/A	Gutter Lip Ht (in)	N/A	N/A	Gutter X Slope (%)	N/A
N/A	Painted X Walk1?	No	N/A	Painted X Walk2?	N/A
	X Walk 1 Direction	To W		X Walk 2 Direction	N/A
N/A	X Walk 1 Width (in)	N/A	N/A	X Walk 2 Width (in)	N/A
	X Walk 1 Slope (%)	4.1		X Walk 2 Slope (%)	N/A
	X Walk 1 X Slope (%)	2.9		X Walk 2 X Slope (%)	N/A

N/A	Ramp inside XWalk1?	N/A	N/A	Ramp inside XWalk2?	N/A
	Road Slope (%)	N/A	N/A	Clear Space?	N/A
	Road X Slope (%)	N/A	N/A	Clear Space to XWalk (in)	N/A
N/A	Any Obstructions?	N/A	N/A	Storm Grate/Utility Hazard?	N/A
	Obstruction Type			Storm Grate/Utility Type	
		N/A			N/A
			Yes	Surface Condition? (G/P)	Good

**Remove & Replace Entire Ramp.**

**R304.5.1**

**\$ 1850.00**
