## **Access Compliance Report Public Rights-of-Way** (Curb Ramps)

Intersection ID: 10405 Main Street: HERRIN\_AV Cross Street: OAKWOOD\_AV Location: SE **Overall Compliance: No** Severity Score: 33.75 ADA ID: BDF340A69A33 Ramp Type: Perp Initial Pass/Fail: Fail

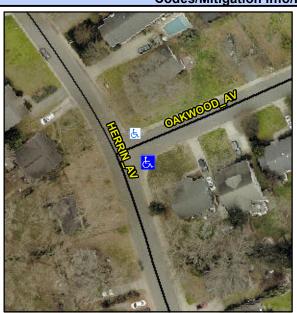
| Possible Solutions: | | | | |
|---|--|--|--|--|
| Not Found, R304.5.1, R304.5.3 | | | | |
| Not Found, R504.5.1, R504.5.5 | | | | |

| Field Measurements/Component Compliance | | | | | | | |
|---|---|---|---|---|---|--|--|
| No | Ramp Width (in) | 44.0 | No | lo Ramp XSlope (%) | | | |

| Possible Solutions: | | | | |
|---|--|--|--|--|
| Remove & Replace Entire Ramp. | | | | |
