# Access Compliance Report

## Public Rights-of-Way

### (Curb Ramps)

Intersection ID: 9857	Main Street: BRISTOL_FORD_PL	Cross Street: TENDRING_CT	Location:	NW
ADA ID: BE01B50D0314	Ramp Type: Perp	Initial Pass/Fail: Fail	Overall Compliance: No	Severity Score: 10

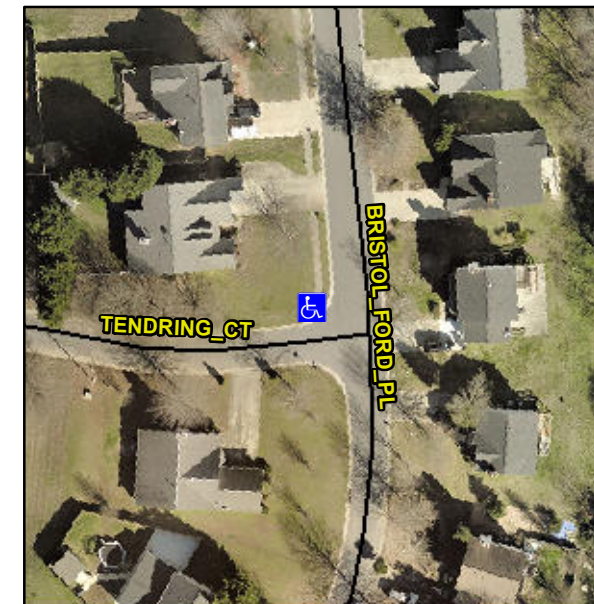
**Not Found, R304.5.1, R304.5.3**

Compliance	Description	Data	Compliance	Description	Data
N/A	Ramp Length (in)	49.0	Yes	Ramp Slope (%)	7.8
No	Ramp Width (in)	46.0	No	Ramp XSlope (%)	2.2
N/A	Flare Type LT	N/A	N/A	Flare Type RT	N/A
N/A	Flare Slope LT (%)	N/A	N/A	Flare Slope RT (%)	N/A
N/A	Flare Traversable LT?	N/A	N/A	Flare Traversable RT?	N/A
N/A	Landing Length (in)	N/A	N/A	DWS Provided?	N/A
N/A	Landing Width (in)	N/A	N/A	DWS Contrast?	N/A
N/A	Landing Slope (%)	N/A	N/A	DWS Length (in)	N/A
N/A	Landing X Slope (%)	N/A	N/A	DWS Full Width?	N/A
N/A	Landing Curb? (Y/N)	N/A	N/A	DWS Offset (in)	N/A
N/A	Shared Landing?	N/A			
N/A	Gutter Ponding?	N/A	N/A	Gutter Slope (%)	N/A
N/A	Gutter Lip Ht (in)	0.5	N/A	Gutter X Slope (%)	N/A
N/A	Painted X Walk1?	No	N/A	Painted X Walk2?	N/A
	X Walk 1 Direction	To S		X Walk 2 Direction	N/A
N/A	X Walk 1 Width (in)	N/A	N/A	X Walk 2 Width (in)	N/A
	X Walk 1 Slope (%)	3.6		X Walk 2 Slope (%)	N/A
	X Walk 1 X Slope (%)	1.5		X Walk 2 X Slope (%)	N/A

N/A	Ramp inside XWalk1?	N/A	N/A	Ramp inside XWalk2?	N/A
	Road Slope (%)	N/A	N/A	Clear Space?	N/A
	Road X Slope (%)	N/A	N/A	Clear Space to XWalk (in)	N/A
N/A	Any Obstructions?	N/A	N/A	Storm Grate/Utility Hazard?	N/A
	Obstruction Type			Storm Grate/Utility Type	
		N/A			N/A
			Yes	Surface Condition? (G/P)	Good

**Remove & Replace Entire Ramp.**

Total Cost: \$ 1850.00
