Access Compliance Report

Public Rights-of-Way

(Curb Ramps)

Intersection ID: 42947	Main Street: MOONDANCE_LN	Cross Street: SEBASTIANI_DR	Location: SW
ADA ID: BE045926A722	Ramp Type: PerpDiag	Initial Pass/Fail: Fail	Overall Compliance: No
		Severity Score: 10

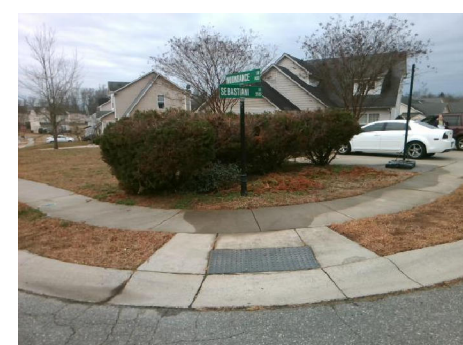
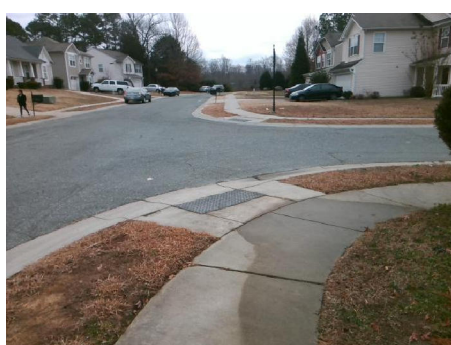
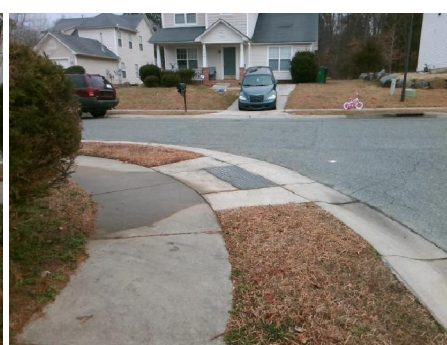
Not Found, R304.5.1, R304.5.3

Compliance	Description	Data	Compliance	Description	Data
N/A	Ramp Length (in)	48.0	Yes	Ramp Slope (%)	6.2
No	Ramp Width (in)	43.0	No	Ramp XSlope (%)	3.2
N/A	Flare Type LT	N/A	N/A	Flare Type RT	N/A
N/A	Flare Slope LT (%)	N/A	N/A	Flare Slope RT (%)	N/A
N/A	Flare Traversable LT?	N/A	N/A	Flare Traversable RT?	N/A
N/A	Landing Length (in)	N/A	N/A	DWS Provided?	N/A
N/A	Landing Width (in)	N/A	N/A	DWS Contrast?	N/A
N/A	Landing Slope (%)	N/A	N/A	DWS Length (in)	N/A
N/A	Landing X Slope (%)	N/A	N/A	DWS Full Width?	N/A
N/A	Landing Curb? (Y/N)	N/A	N/A	DWS Offset (in)	N/A
N/A	Shared Landing?	N/A			
N/A	Gutter Ponding?	N/A	N/A	Gutter Slope (%)	N/A
N/A	Gutter Lip Ht (in)	N/A	N/A	Gutter X Slope (%)	N/A
N/A	Painted X Walk1?	No	N/A	Painted X Walk2?	No
	X Walk 1 Direction	To E		X Walk 2 Direction	To N
N/A	X Walk 1 Width (in)	N/A	N/A	X Walk 2 Width (in)	N/A
	X Walk 1 Slope (%)	4.6		X Walk 2 Slope (%)	3.9
	X Walk 1 X Slope (%)	3.7		X Walk 2 X Slope (%)	1.3

N/A	Ramp inside XWalk1?	N/A	N/A	Ramp inside XWalk2?	N/A
	Road Slope (%)	2.7	N/A	Clear Space?	N/A
	Road X Slope (%)	3.9	N/A	Clear Space to XWalk (in)	N/A
N/A	Any Obstructions?	N/A	N/A	Storm Grate/Utility Hazard?	N/A
	Obstruction Type			Storm Grate/Utility Type	
		N/A			N/A
			Yes	Surface Condition? (G/P)	Good

Remove & Replace Curb Ramp With Two New Directional Ramps or Equivalent.
