Access Compliance Report

Public Rights-of-Way

(Curb Ramps)

Intersection ID: 18052	Main Street: RANDOLPH_RD	Cross Street: GAYNOR_RD	Location: NE
ADA ID: BE0AEAC2293B	Ramp Type: PerpDiag	Initial Pass/Fail: Fail	Overall Compliance: No
		Severity Score: 22.5

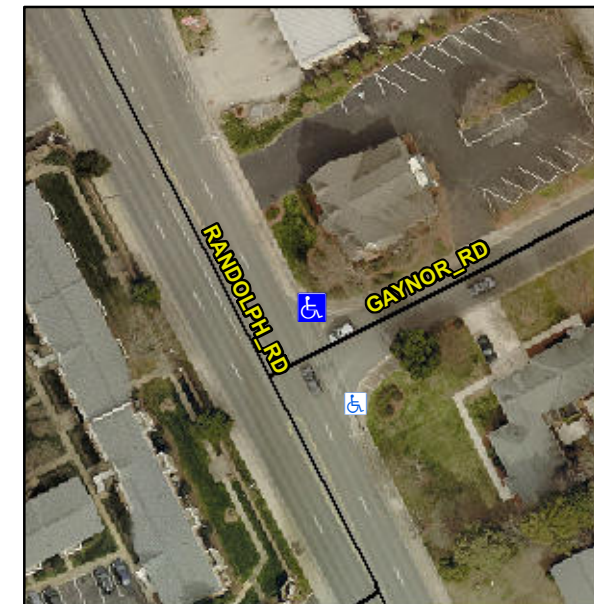
Not Found, R304.5.1, R304.2.2, R304.5.3

Compliance	Description	Data	Compliance	Description	Data
N/A	Ramp Length (in)	74.0	No	Ramp Slope (%)	9.8
No	Ramp Width (in)	36.0	No	Ramp XSlope (%)	2.3
N/A	Flare Type LT	N/A	N/A	Flare Type RT	N/A
N/A	Flare Slope LT (%)	N/A	N/A	Flare Slope RT (%)	N/A
N/A	Flare Traversable LT?	N/A	N/A	Flare Traversable RT?	N/A
N/A	Landing Length (in)	N/A	N/A	DWS Provided?	N/A
N/A	Landing Width (in)	N/A	N/A	DWS Contrast?	N/A
N/A	Landing Slope (%)	N/A	N/A	DWS Length (in)	N/A
N/A	Landing X Slope (%)	N/A	N/A	DWS Full Width?	N/A
N/A	Landing Curb? (Y/N)	N/A	N/A	DWS Offset (in)	N/A
N/A	Shared Landing?	N/A			
N/A	Gutter Ponding?	N/A	N/A	Gutter Slope (%)	N/A
N/A	Gutter Lip Ht (in)	N/A	N/A	Gutter X Slope (%)	N/A
N/A	Painted X Walk1?	No	N/A	Painted X Walk2?	No
	X Walk 1 Direction	To SW		X Walk 2 Direction	To SE
N/A	X Walk 1 Width (in)	N/A	N/A	X Walk 2 Width (in)	N/A
	X Walk 1 Slope (%)	1.6		X Walk 2 Slope (%)	2.3
	X Walk 1 X Slope (%)	3.8		X Walk 2 X Slope (%)	1.3

N/A	Ramp inside XWalk1?	N/A	N/A	Ramp inside XWalk2?	N/A
	Road Slope (%)	0.6	N/A	Clear Space?	N/A
	Road X Slope (%)	4.8	N/A	Clear Space to XWalk (in)	N/A
N/A	Any Obstructions?	N/A	N/A	Storm Grate/Utility Hazard?	N/A
	Obstruction Type			Storm Grate/Utility Type	
		N/A			N/A
			Yes	Surface Condition? (G/P)	Good

Possible Solutions:

Remove & Replace Curb Ramp With Two New Directional Ramps or Equivalent.
