# Access Compliance Report

## Public Rights-of-Way

### (Curb Ramps)

| Intersection ID: 12632 | Main Street: SEIGLE_AV | Cross Street: SKYLINE_VIEW_WY | Location: N |

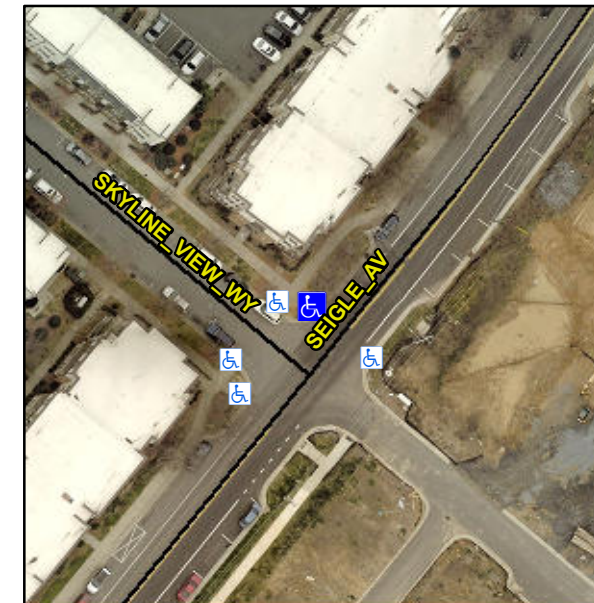
| ADA ID: BE0C1DF701EC | Ramp Type: Directional1 | Initial Pass/Fail: Pass | Overall Compliance: No |
| | | Severity Score: 7.75 | |

**R304.5.3, R304.2.2-Perp, R304.3.2-  
Para, R302.7.2**

| Compliance | Description | Data | Compliance | Description | Data |
|---|---|---|---|---|---|
| Yes | Ramp Width (in) | 70.0 | No | Grade Break Slope (%) | 5.4 |
| No | Ramp XSlope (%) | 3.8 | | | |
| No | Landing Slope (%) | 2.3 | Yes | DWS Length (in) | 25.0 |
| No | Landing X Slope (%) | 3.0 | Yes | DWS Full Width? | Yes |
| No | Gutter Lip Ht (in) | 0.5 | Yes | Gutter X Slope (%) | 3.1 |

**Remove & Replace Entire Ramp.  
Grind Gutter Lip.**
