Access Compliance Report

Public Rights-of-Way

(Curb Ramps)

Intersection ID: 13749	Main Street: BARRINGER_DR	Cross Street: REMOUNT_RD	Location: NE
ADA ID: BE0D595B98EA	Ramp Type: Perp	Initial Pass/Fail: Fail	Overall Compliance: No
Severity Score: 31.25			
Codes/Mitigation Info/Possible Solution		Field Measurements/Component Compliance

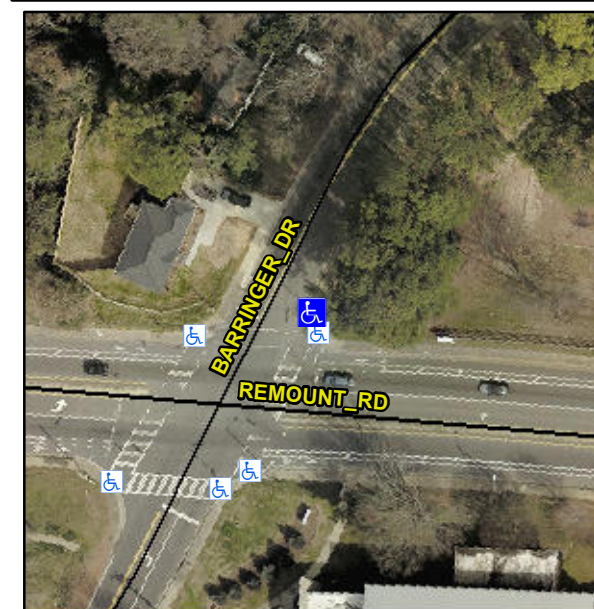
Compliance	Description	Data	Compliance	Description	Data
N/A	Ramp Length (in)	59.0	No	Ramp Slope (%)	8.6
No	Ramp Width (in)	33.0	No	Ramp XSlope (%)	2.2
N/A	Flare Type LT	N/A	N/A	Flare Type RT	N/A
N/A	Flare Slope LT (%)	N/A	N/A	Flare Slope RT (%)	N/A
N/A	Flare Traversable LT?	N/A	N/A	Flare Traversable RT?	N/A
N/A	Landing Length (in)	N/A	N/A	DWS Provided?	N/A
N/A	Landing Width (in)	N/A	N/A	DWS Contrast?	N/A
N/A	Landing Slope (%)	N/A	N/A	DWS Length (in)	N/A
N/A	Landing X Slope (%)	N/A	N/A	DWS Full Width?	N/A
N/A	Landing Curb? (Y/N)	N/A	N/A	DWS Offset (in)	N/A
N/A	Shared Landing?	N/A			
N/A	Gutter Ponding?	N/A	N/A	Gutter Slope (%)	N/A
N/A	Gutter Lip Ht (in)	N/A	N/A	Gutter X Slope (%)	N/A
N/A	Painted X Walk1?	Yes	N/A	Painted X Walk2?	N/A
	X Walk 1 Direction	To S		X Walk 2 Direction	N/A
N/A	X Walk 1 Width (in)	108.0	N/A	X Walk 2 Width (in)	N/A
	X Walk 1 Slope (%)	7.5		X Walk 2 Slope (%)	N/A
	X Walk 1 X Slope (%)	1.5		X Walk 2 X Slope (%)	N/A

N/A	Ramp inside XWalk1?	No	N/A	Ramp inside XWalk2?	N/A
	Road Slope (%)	N/A	N/A	Clear Space?	N/A
	Road X Slope (%)	N/A	N/A	Clear Space to XWalk (in)	N/A
N/A	Any Obstructions?	N/A	N/A	Storm Grate/Utility Hazard?	N/A
	Obstruction Type			Storm Grate/Utility Type	
		N/A			N/A
			Yes	Surface Condition? (G/P)	Good

Possible Solutions:

**Remove & Replace Entire Ramp.
Restripe Crosswalk.**

R304.5.1, R304.2.2, R304.5.3
