Access Compliance Report

Public Rights-of-Way

(Curb Ramps)

Intersection ID: 15296	Main Street: DWIGHTWARE_BV	Cross Street: OLD_MEADOW_RD	Location: NE
ADA ID: BE10768DE967	Ramp Type: PerpDiag	Initial Pass/Fail: Fail	Overall Compliance: No
Codes/Mitigation Info/Possible Solution		Field Measurements/Component Compliance	
Severity Score: 8.75

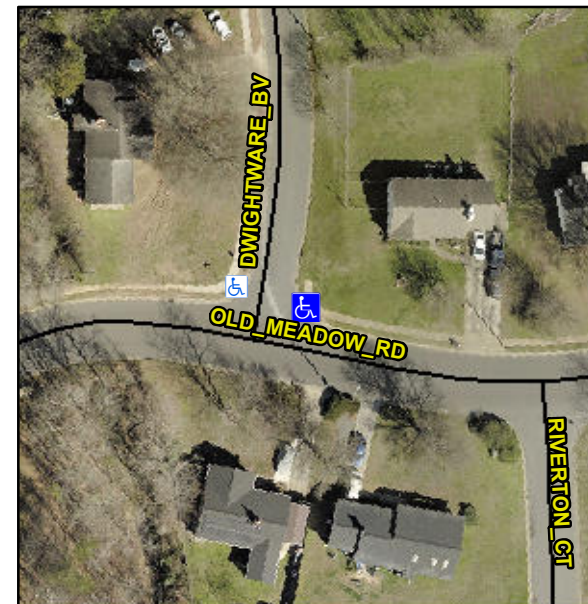
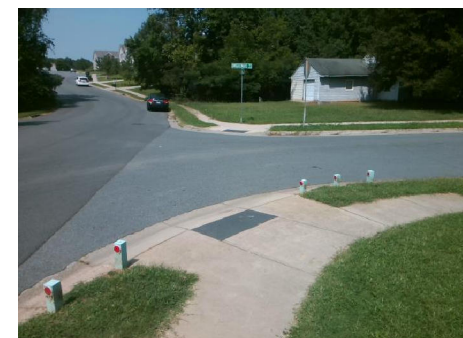
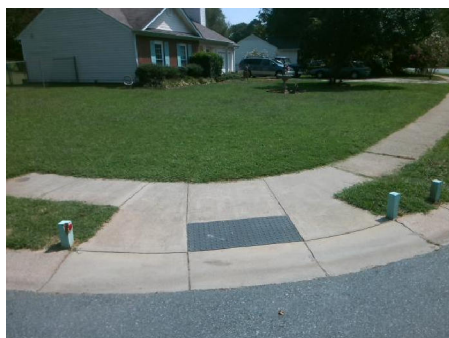
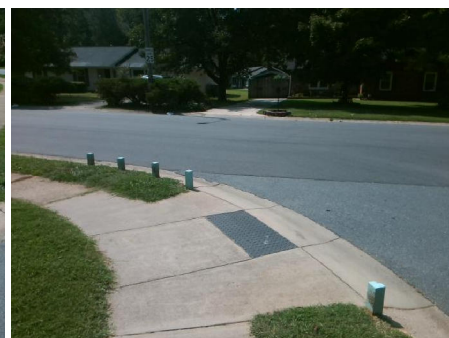
Not Found, R304.5.1

Compliance	Description	Data	Compliance	Description	Data
N/A	Ramp Length (in)	81.0	Yes	Ramp Slope (%)	5.0
No	Ramp Width (in)	47.0	Yes	Ramp XSlope (%)	1.9
N/A	Flare Type LT	N/A	N/A	Flare Type RT	N/A
N/A	Flare Slope LT (%)	N/A	N/A	Flare Slope RT (%)	N/A
N/A	Flare Traversable LT?	N/A	N/A	Flare Traversable RT?	N/A
N/A	Landing Length (in)	N/A	N/A	DWS Provided?	N/A
N/A	Landing Width (in)	N/A	N/A	DWS Contrast?	N/A
N/A	Landing Slope (%)	N/A	N/A	DWS Length (in)	N/A
N/A	Landing X Slope (%)	N/A	N/A	DWS Full Width?	N/A
N/A	Landing Curb? (Y/N)	N/A	N/A	DWS Offset (in)	N/A
N/A	Shared Landing?	N/A			
N/A	Gutter Ponding?	N/A	N/A	Gutter Slope (%)	N/A
N/A	Gutter Lip Ht (in)	N/A	N/A	Gutter X Slope (%)	N/A
N/A	Painted X Walk1?	No	N/A	Painted X Walk2?	No
	X Walk 1 Direction	To NW		X Walk 2 Direction	To SW
N/A	X Walk 1 Width (in)	N/A	N/A	X Walk 2 Width (in)	N/A
	X Walk 1 Slope (%)	2.3		X Walk 2 Slope (%)	2.5
	X Walk 1 X Slope (%)	2.3		X Walk 2 X Slope (%)	0.4

N/A	Ramp inside XWalk1?	N/A	N/A	Ramp inside XWalk2?	N/A
	Road Slope (%)	1.1	N/A	Clear Space?	N/A
	Road X Slope (%)	4.0	N/A	Clear Space to XWalk (in)	N/A
N/A	Any Obstructions?	N/A	N/A	Storm Grate/Utility Hazard?	N/A
	Obstruction Type			Storm Grate/Utility Type	
		N/A			N/A
			Yes	Surface Condition? (G/P)	Good

Possible Solutions:

Remove & Replace Curb Ramp With Two New Directional Ramps or Equivalent.
