# Access Compliance Report

## Public Rights-of-Way

### (Curb Ramps)

Intersection ID: 15970	Main Street: COUNTRY_WALK_DR	Cross Street: REDDMAN_RD	Location: SE
ADA ID: BE1825F05749	Ramp Type: PerpDiag	Initial Pass/Fail: Fail	Overall Compliance: No
		Severity Score: 12.5

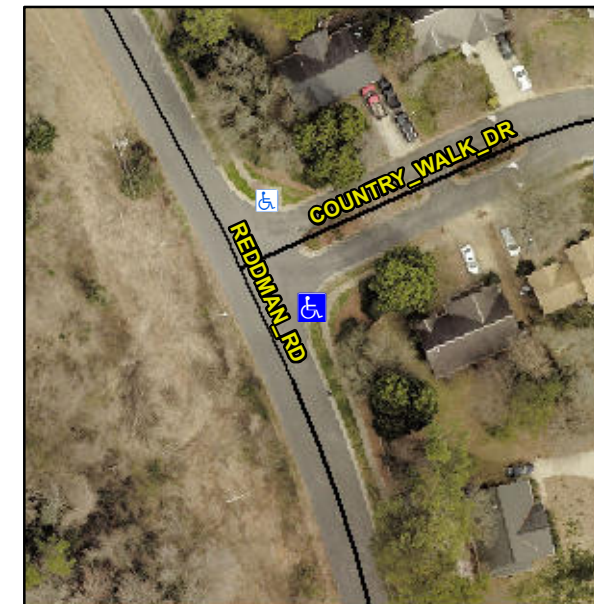
Compliance	Description	Data	Compliance	Description	Data
N/A	Ramp Length (in)	26.5	Yes	Ramp Slope (%)	5.4
Yes	Ramp Width (in)	48.0	No	Ramp XSlope (%)	5.7
N/A	Flare Type LT	N/A	N/A	Flare Type RT	N/A
N/A	Flare Slope LT (%)	N/A	N/A	Flare Slope RT (%)	N/A
N/A	Flare Traversable LT?	N/A	N/A	Flare Traversable RT?	N/A
N/A	Landing Length (in)	N/A	N/A	DWS Provided?	N/A
N/A	Landing Width (in)	N/A	N/A	DWS Contrast?	N/A
N/A	Landing Slope (%)	N/A	N/A	DWS Length (in)	N/A
N/A	Landing X Slope (%)	N/A	N/A	DWS Full Width?	N/A
N/A	Landing Curb? (Y/N)	N/A	N/A	DWS Offset (in)	N/A
N/A	Shared Landing?	N/A			
N/A	Gutter Ponding?	N/A	N/A	Gutter Slope (%)	N/A
N/A	Gutter Lip Ht (in)	N/A	N/A	Gutter X Slope (%)	N/A
N/A	Painted X Walk1?	No	N/A	Painted X Walk2?	No
	X Walk 1 Direction	To NW		X Walk 2 Direction	To W
N/A	X Walk 1 Width (in)	N/A	N/A	X Walk 2 Width (in)	N/A
	X Walk 1 Slope (%)	6.0		X Walk 2 Slope (%)	0.9
	X Walk 1 X Slope (%)	2.5		X Walk 2 X Slope (%)	5.4

N/A	Ramp inside XWalk1?	N/A	N/A	Ramp inside XWalk2?	N/A
	Road Slope (%)	5.0	N/A	Clear Space?	N/A
	Road X Slope (%)	2.7	N/A	Clear Space to XWalk (in)	N/A
N/A	Any Obstructions?	N/A	N/A	Storm Grate/Utility Hazard?	N/A
	Obstruction Type			Storm Grate/Utility Type	
		N/A			N/A
			Yes	Surface Condition? (G/P)	Good

**Remove & Replace Curb Ramp With Two New Directional Ramps or Equivalent.**

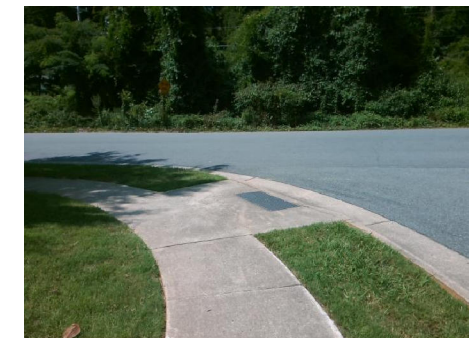
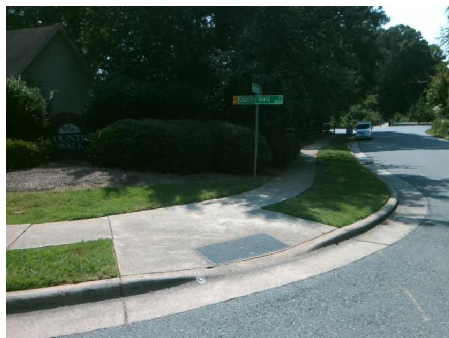
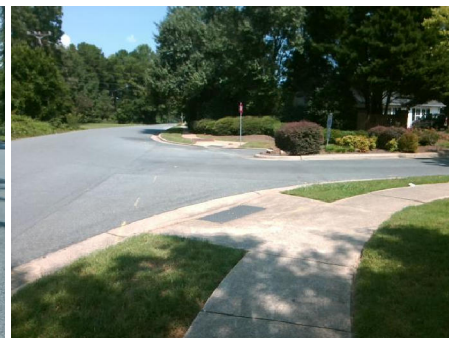
Street 1 Name COUNTRY WALK DR  
 Stop Condition-Street 2 StopSign  
 Street 2 Name REDDMAN RD  
 Stop Condition-Street 1 None
