Access Compliance Report

Public Rights-of-Way

(Curb Ramps)

| Intersection ID: 11823 | Main Street: N_ALEXANDER_ST | Cross Street: E_15TH_ST | Location: E |

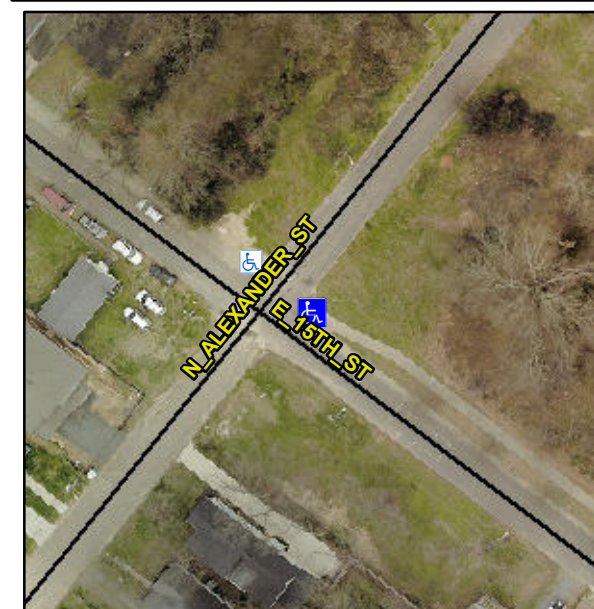
| ADA ID: BE20B01D73A9 | Ramp Type: Perp | Initial Pass/Fail: Fail | Overall Compliance: No |
| Severity Score: 17.5 | | | |

Not Found, R304.5.1

| Compliance | Description | Data | Compliance | Description | Data |
|---|---|---|---|---|---|
| N/A | Ramp Length (in) | 89.0 | Yes | Ramp Slope (%) | 5.4 |
| No | Ramp Width (in) | 32.0 | Yes | Ramp XSlope (%) | 2.0 |

Possible Solutions:

Remove & Replace Entire Ramp.

Total Cost: \$ 1850.00
