# Access Compliance Report

## Public Rights-of-Way

### (Curb Ramps)

Intersection ID: 6787	Main Street: N_GRAHAM_ST	Cross Street: PRINCESS_ST	Location: S
ADA ID: BE238D2FE312	Ramp Type: Perp	Initial Pass/Fail: Fail	Overall Compliance: No
Severity Score: 21.25			
Codes/Mitigation Info/Possible Solution		Field Measurements/Component Compliance

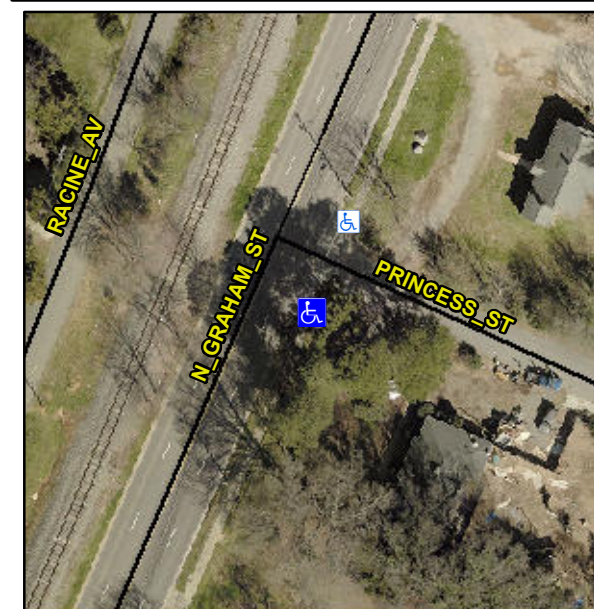
**Not Found, R304.5.1, R304.2.2**

Compliance	Description	Data	Compliance	Description	Data
N/A	Ramp Length (in)	43.0	No	Ramp Slope (%)	9.3
No	Ramp Width (in)	42.0	Yes	Ramp XSlope (%)	1.3
N/A	Flare Type LT	N/A	N/A	Flare Type RT	N/A
N/A	Flare Slope LT (%)	N/A	N/A	Flare Slope RT (%)	N/A
N/A	Flare Traversable LT?	N/A	N/A	Flare Traversable RT?	N/A
N/A	Landing Length (in)	N/A	N/A	DWS Provided?	N/A
N/A	Landing Width (in)	N/A	N/A	DWS Contrast?	N/A
N/A	Landing Slope (%)	N/A	N/A	DWS Length (in)	N/A
N/A	Landing X Slope (%)	N/A	N/A	DWS Full Width?	N/A
N/A	Landing Curb? (Y/N)	N/A	N/A	DWS Offset (in)	N/A
N/A	Shared Landing?	N/A			
N/A	Gutter Ponding?	N/A	N/A	Gutter Slope (%)	N/A
N/A	Gutter Lip Ht (in)	2.0	N/A	Gutter X Slope (%)	N/A
N/A	Painted X Walk1?	No	N/A	Painted X Walk2?	N/A
	X Walk 1 Direction	To NE		X Walk 2 Direction	N/A
N/A	X Walk 1 Width (in)	N/A	N/A	X Walk 2 Width (in)	N/A
	X Walk 1 Slope (%)	2.8		X Walk 2 Slope (%)	N/A
	X Walk 1 X Slope (%)	1.8		X Walk 2 X Slope (%)	N/A

**Remove & Replace Entire Ramp.**

Total Cost: \$ 1850.00
