Access Compliance Report

Public Rights-of-Way

(Curb Ramps)

Intersection ID: 22553	Main Street: CHESTNUT GROVE LN	Cross Street: MAGNOLIA BRIDGE RD	Location: NE
ADA ID: BE27C8EC1AD4	Ramp Type: PerpDiag	Initial Pass/Fail: Fail	Overall Compliance: No
Severity Score: 13.75			
Codes/Mitigation Info/Possible Solution		Field Measurements/Component Compliance

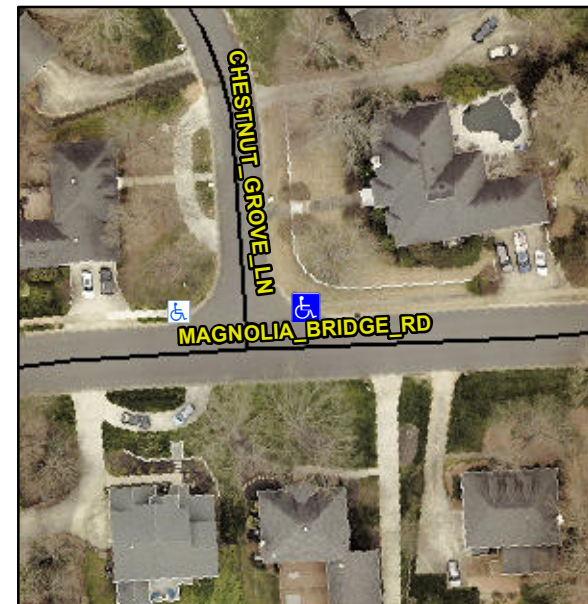
Not Found, R304.2.2, R304.5.3

Compliance	Description	Data	Compliance	Description	Data
N/A	Ramp Length (in)	40.0	No	Ramp Slope (%)	8.6
Yes	Ramp Width (in)	48.0	No	Ramp XSlope (%)	2.6
N/A	Flare Type LT	N/A	N/A	Flare Type RT	N/A
N/A	Flare Slope LT (%)	N/A	N/A	Flare Slope RT (%)	N/A
N/A	Flare Traversable LT?	N/A	N/A	Flare Traversable RT?	N/A
N/A	Landing Length (in)	N/A	N/A	DWS Provided?	N/A
N/A	Landing Width (in)	N/A	N/A	DWS Contrast?	N/A
N/A	Landing Slope (%)	N/A	N/A	DWS Length (in)	N/A
N/A	Landing X Slope (%)	N/A	N/A	DWS Full Width?	N/A
N/A	Landing Curb? (Y/N)	N/A	N/A	DWS Offset (in)	N/A
N/A	Shared Landing?	N/A			
N/A	Gutter Ponding?	N/A	N/A	Gutter Slope (%)	N/A
N/A	Gutter Lip Ht (in)	N/A	N/A	Gutter X Slope (%)	N/A
N/A	Painted X Walk1?	No	N/A	Painted X Walk2?	No
	X Walk 1 Direction	To W		X Walk 2 Direction	To S
N/A	X Walk 1 Width (in)	N/A	N/A	X Walk 2 Width (in)	N/A
	X Walk 1 Slope (%)	6.7		X Walk 2 Slope (%)	0.2
	X Walk 1 X Slope (%)	10.2		X Walk 2 X Slope (%)	5.0

N/A	Ramp inside XWalk1?	N/A	N/A	Ramp inside XWalk2?	N/A
	Road Slope (%)	0.2	N/A	Clear Space?	N/A
	Road X Slope (%)	14.1	N/A	Clear Space to XWalk (in)	N/A
N/A	Any Obstructions?	N/A	N/A	Storm Grate/Utility Hazard?	N/A
	Obstruction Type			Storm Grate/Utility Type	
		N/A			N/A
		Yes		Surface Condition? (G/P)	Good

Remove & Replace Curb Ramp With Two New Directional Ramps or Equivalent.
