# Access Compliance Report

## Public Rights-of-Way

### (Curb Ramps)

Intersection ID: 11494	Main Street: BECKWITH_PL	Cross Street: EAST_FORD_RD	Location: W
ADA ID: BE2C8CD30CE7	Ramp Type: Directional1	Initial Pass/Fail: Fail	Overall Compliance: No
		Severity Score: 12.5

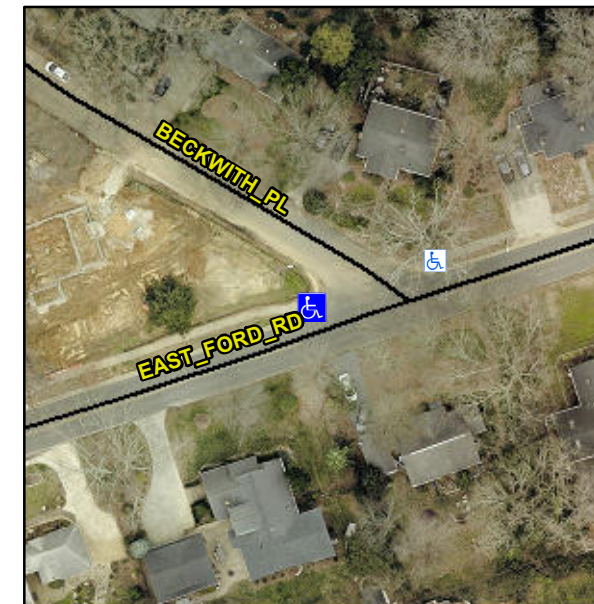
Compliance	Description	Data	Compliance	Description	Data
N/A	Ramp Length (in)	119.0	N/A	Grade Break?	N/A
Yes	Ramp Width (in)	59.0	N/A	Grade Break Slope (%)	0.0
No	Ramp Slope (%)	10.0	N/A	Grade Break XSlope (%)	0.0
Yes	Ramp XSlope (%)	0.9			
N/A	Flare Type LT	N/A	N/A	Flare Type RT	N/A
N/A	Flare Slope LT (%)	N/A	N/A	Flare Slope RT (%)	0.0
N/A	Flare Traversable LT?	N/A	N/A	Flare Traversable RT?	N/A
N/A	Landing Length (in)	0.0	N/A	DWS Provided?	N/A
N/A	Landing Width (in)	0.0	N/A	DWS Contrast?	N/A
N/A	Landing Slope (%)	0.0	N/A	DWS Length (in)	N/A
N/A	Landing X Slope (%)	0.0	N/A	DWS Full Width?	N/A
N/A	Landing Curb? (Y/N)	N/A	N/A	DWS Offset LT (in)	N/A
N/A	Shared Landing?	N/A	N/A	DWS Offset RT (in)	N/A
N/A	Gutter Ponding?	0.0	N/A	Gutter Slope (%)	N/A
N/A	Gutter Lip Ht (in)	0.0	N/A	Gutter X Slope (%)	N/A
N/A	Painted X Walk1?	No		Road Slope (%)	2.9
	X Walk 1 Direction	To E		Road X Slope (%)	1.7
	X Walk 1 Width (in)	N/A		Clear Space?	N/A

X Walk 1 Slope (%)	2.9	N/A	Clear Space to XWalk (in)	N/A
	X Walk 1 X Slope (%)	1.7	N/A	Storm Grate/Utility Hazard?	N/A
N/A	Ramp inside XWalk1?	N/A		Storm Grate/Utility Type	
N/A	Any Obstructions?	N/A			N/A
	Obstruction Type		Yes	Surface Condition? (G/P)	Good
			N/A	Curb Slope (%)	16.6

Possible Solutions:

**Remove & Replace Entire Ramp.**

PROW/ADA:

**R304.2.2**
