# Access Compliance Report

## Public Rights-of-Way

### (Curb Ramps)

| Intersection ID: 48160 | Main Street: NORTHLAKE CENTRE PY | Cross Street: N/A | Location: SE |

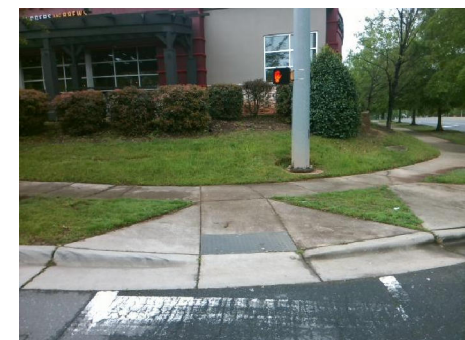
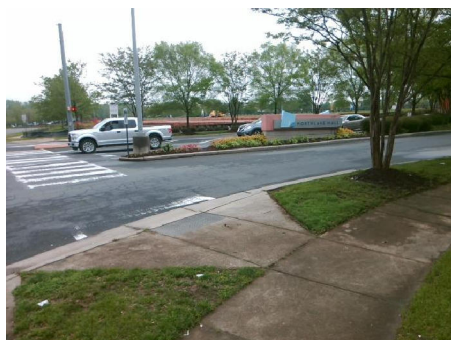
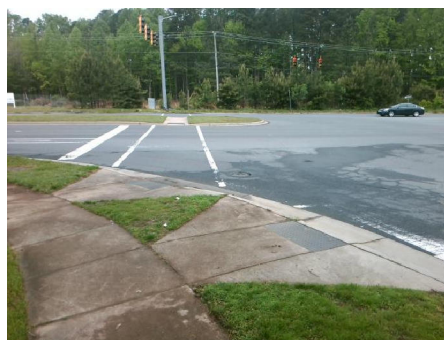
| ADA ID: BE3A9F4FD682 | Ramp Type: BlendTrans1 | Initial Pass/Fail: Pass | Overall Compliance: No |
| Severity Score: 0.25 | | | |

**Not Found, R302.7**

| Compliance | Description | Data | Compliance | Description | Data |
|---|---|---|---|---|---|
| | | | No | Curb Slope (%) | 16.1 |

**Remove & Replace Curb Slope and Extend Ramp.**

Total Cost: \$ 2000.00
