Access Compliance Report

Public Rights-of-Way

(Curb Ramps)

Intersection ID: 10020719	Main Street: BEATTIES_FORD_RD	Cross Street: N/A	Location: W
ADA ID: BE3D3688E09C	Ramp Type: Perp	Initial Pass/Fail: Fail	Overall Compliance: No
Severity Score: 12.5			
Codes/Mitigation Info/Possible Solution		Field Measurements/Component Compliance

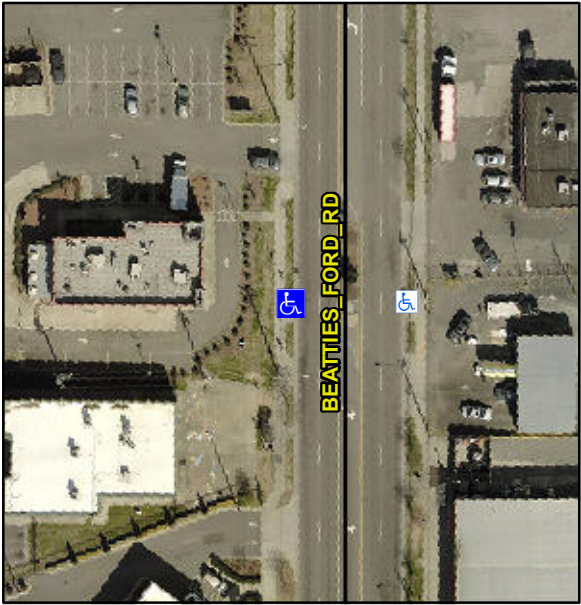
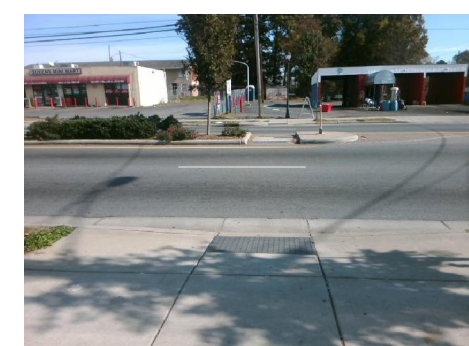
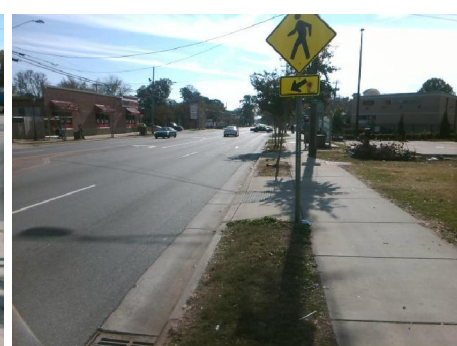
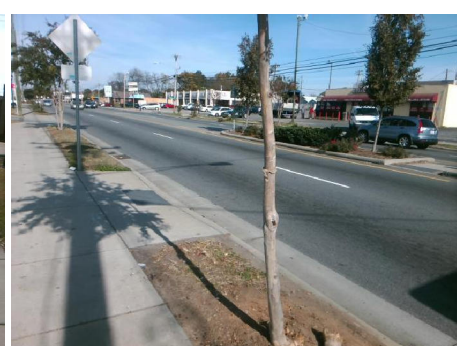
Possible Solutions:						
	Remove & Replace Entire Ramp.	N/A	Ramp Length (in)	48.0	No	Ramp Slope (%)	10.9
		Yes	Ramp Width (in)	48.0	Yes	Ramp XSlope (%)	0.1
		N/A	Flare Type LT	N/A	N/A	Flare Type RT	N/A
		N/A	Flare Slope LT (%)	N/A	N/A	Flare Slope RT (%)	N/A
		N/A	Flare Traversable LT?	N/A	N/A	Flare Traversable RT?	N/A
		N/A	Landing Length (in)	N/A	N/A	DWS Provided?	N/A
		N/A	Landing Width (in)	N/A	N/A	DWS Contrast?	N/A
		N/A	Landing Slope (%)	N/A	N/A	DWS Length (in)	N/A
		N/A	Landing X Slope (%)	N/A	N/A	DWS Full Width?	N/A
		N/A	Landing Curb? (Y/N)	N/A	N/A	DWS Offset (in)	N/A
		N/A	Shared Landing?	N/A			
		N/A	Gutter Ponding?	N/A	N/A	Gutter Slope (%)	N/A
		N/A	Gutter Lip Ht (in)	N/A	N/A	Gutter X Slope (%)	N/A
		N/A	Painted X Walk1?	No	N/A	Painted X Walk2?	N/A
			X Walk 1 Direction	To E		X Walk 2 Direction	N/A
		N/A	X Walk 1 Width (in)	N/A	N/A	X Walk 2 Width (in)	N/A
			X Walk 1 Slope (%)	3.0		X Walk 2 Slope (%)	N/A

X Walk 1 X Slope (%)	0.6		X Walk 2 X Slope (%)	N/A
		N/A	Ramp inside XWalk1?	N/A	N/A	Ramp inside XWalk2?	N/A
<p>Surveyor Notes:</p> <p>N/A</p> <p>PROW/ADA:</p> <p>Not Found, R304.2.2</p>			Road Slope (%)	N/A	N/A	Clear Space?	N/A
			Road X Slope (%)	N/A	N/A	Clear Space to XWalk (in)	N/A
		N/A	Any Obstructions?	N/A	N/A	Storm Grate/Utility Hazard?	N/A
			Obstruction Type			Storm Grate/Utility Type	
					N/A		N/A
					Yes	Surface Condition? (G/P)	Good
