Access Compliance Report Public Rights-of-Way (Curb Ramps)

Intersection ID: 13639Main Street:BRIAR_CREEK_RDCross Street:CENTRAL_AVLocation:NWADA ID: BE41FA45A167Ramp Type:PerpInitial Pass/Fail:FailOverall Compliance:NoSeverity Score:10

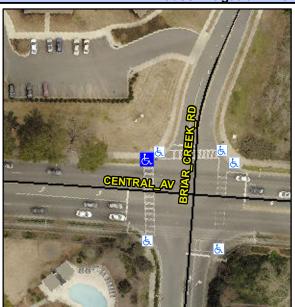
b/Possible Solution Field Measurements/Component Compliance								
Possible Solutions:		Comp	liance Description	Data	Comp	liance	Description	Data
Remove & Replace Entire R	Ramp.	N/A	Ramp Length (in)	52.0	Yes	Ramp	Slope (%)	6.8

•	•	No	Ramp Width (in)	47.0	Yes	Ramp	XSlope (%)	3.3
		N/A	Flare Type LT	N/A	N/A	Flare	ype RT	N/A
		N/A	Flare Slope LT (%)	N/A	N/A	Flare S	Slope RT (%)	N/A
		N/A	Flare Traversable LT?	N/A	N/A	Flare	raversable RT?	N/A
		N/A	Landing Length (in)	N/A	N/A	DWS I	Provided?	N/A
Surveyor Notes:		N/A	Landing Width (in)	N/A	N/A	DWS (Contrast?	N/A
N/A		N/A	Landing Slope (%)	N/A	N/A	DWS I	ength (in)	N/A
		N/A	Landing X Slope (%)	N/A	N/A	DWS I	Full Width?	N/A
2		N/A	Landing Curb? (Y/N)	N/A	N/A	DWS (Offset (in)	N/A
		N/A	Shared Landing?	N/A				
PROW/ADA:		N/A	Gutter Ponding?	N/A	N/A	Gutter	Slope (%)	N/A
Not Found, R304.5.1		N/A	Gutter Lip Ht (in)	N/A	N/A	Gutter	X Slope (%)	N/A
		N/A	Painted X Walk1?	Yes	N/A	Painte	d X Walk2?	N/A
			X Walk 1 Direction	To S		X Wall	c 2 Direction	N/A
		N/A	X Walk 1 Width (in)	105.0	N/A	X Wall	c 2 Width (in)	N/A
			X Walk 1 Slope (%)	2.5		X Wall	(2 Slope (%)	N/A
			X Walk 1 X Slope (%)	3.3		X Wall	(2 X Slope (%)	N/A

N/A	Ramp inside XWalk1?	Yes	N/A	Ramp	inside XWalk2?	N/A
			Road Slope (%)	N/A	N/A	Clear	Space?	N/A
			Road X Slope (%)	N/A	N/A	Clear	Space to XWalk (in)	N/A
		N/A	Any Obstructions?	N/A	N/A	Storm	Grate/Utility Hazard?	N/A
Total Cost:	\$ 1850.00		Obstruction Type		l	Storm	Grate/Utility Type	
				N/A				N/A
					Yes	Surfac	e Condition? (G/P)	Good
