Access Compliance Report

Public Rights-of-Way

(Curb Ramps)

Intersection ID: 10020383	Main Street: BALLANTYNE_COUNTRY_CLUB_DR	Cross Street: N/A	Location: SE
ADA ID: BE4405D39C8C	Ramp Type: PerpDiag	Initial Pass/Fail: Fail	Overall Compliance: No
Severity Score: 12.5			
Codes/Mitigation Info/Possible Solution		Field Measurements/Component Compliance

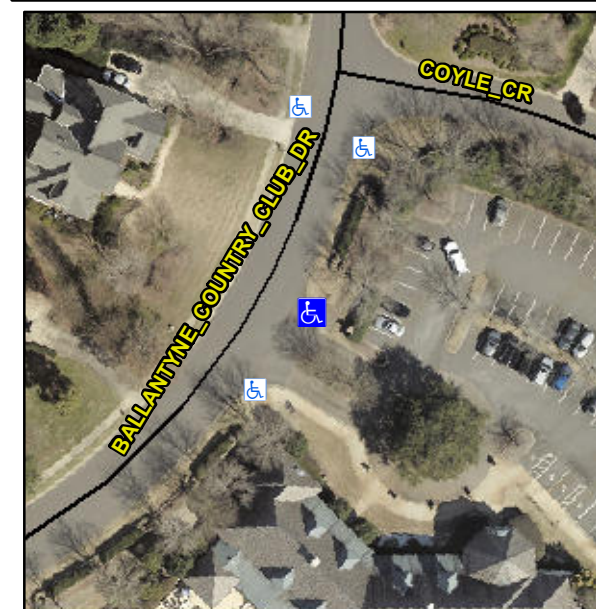
Compliance	Description	Data	Compliance	Description	Data
N/A	Ramp Length (in)	126.0	Yes	Ramp Slope (%)	5.6
Yes	Ramp Width (in)	48.0	No	Ramp XSlope (%)	5.3
N/A	Flare Type LT	N/A	N/A	Flare Type RT	N/A
N/A	Flare Slope LT (%)	N/A	N/A	Flare Slope RT (%)	N/A
N/A	Flare Traversable LT?	N/A	N/A	Flare Traversable RT?	N/A
N/A	Landing Length (in)	N/A	N/A	DWS Provided?	N/A
N/A	Landing Width (in)	N/A	N/A	DWS Contrast?	N/A
N/A	Landing Slope (%)	N/A	N/A	DWS Length (in)	N/A
N/A	Landing X Slope (%)	N/A	N/A	DWS Full Width?	N/A
N/A	Landing Curb? (Y/N)	N/A	N/A	DWS Offset (in)	N/A
N/A	Shared Landing?	N/A			
N/A	Gutter Ponding?	N/A	N/A	Gutter Slope (%)	N/A
N/A	Gutter Lip Ht (in)	N/A	N/A	Gutter X Slope (%)	N/A
N/A	Painted X Walk1?	No	N/A	Painted X Walk2?	No
	X Walk 1 Direction	To NE		X Walk 2 Direction	To NW
N/A	X Walk 1 Width (in)	N/A	N/A	X Walk 2 Width (in)	N/A
	X Walk 1 Slope (%)	0.3		X Walk 2 Slope (%)	1.8
	X Walk 1 X Slope (%)	4.2		X Walk 2 X Slope (%)	2.8

N/A	Ramp inside XWalk1?	N/A	N/A	Ramp inside XWalk2?	N/A
	Road Slope (%)	3.8	N/A	Clear Space?	N/A
	Road X Slope (%)	2.6	N/A	Clear Space to XWalk (in)	N/A
N/A	Any Obstructions?	N/A	N/A	Storm Grate/Utility Hazard?	N/A
	Obstruction Type			Storm Grate/Utility Type	
		N/A			N/A
		Yes		Surface Condition? (G/P)	Good

Possible Solutions:

Remove & Replace Curb Ramp With Two New Directional Ramps or Equivalent.

R304.5.3
