Intersection ID: 9622	Main Street: FAIRFIELD_ST	Cross Street: WASHINGTON_AV	Location:	E
ADA ID: BE47EA0618D7	Ramp Type: Perp	Initial Pass/Fail: Fail	Overall Compliance: No	Severity Score: 10

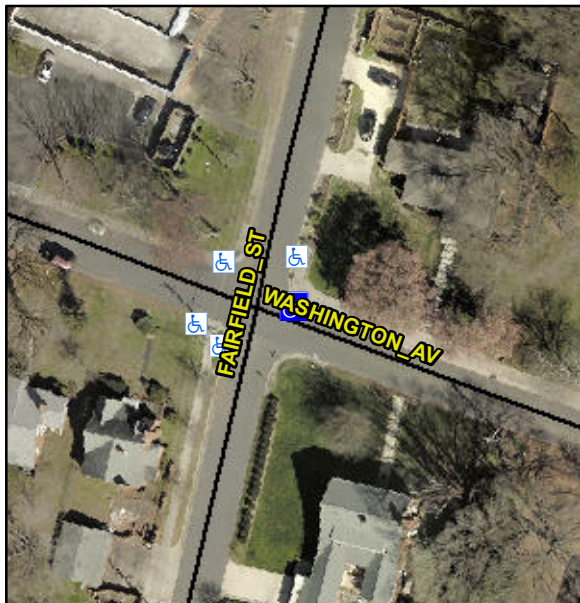
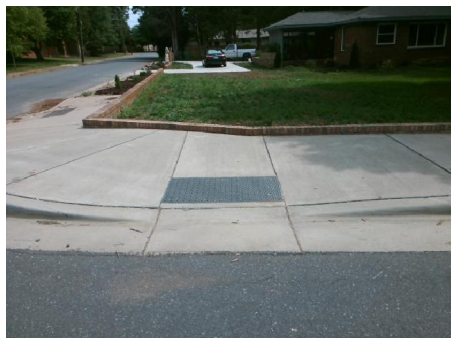
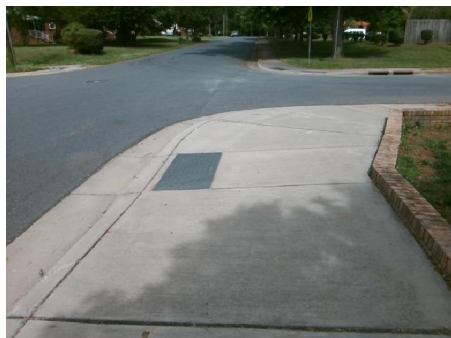
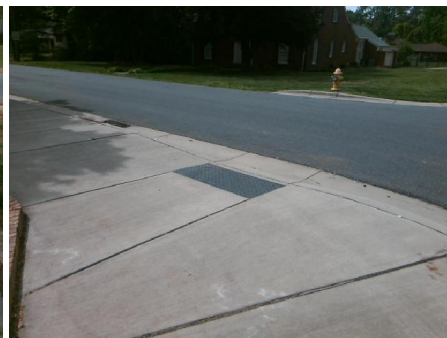
Compliance	Description	Data	Compliance	Description	Data
N/A	Ramp Length (in)	91.0	Yes	Ramp Slope (%)	6.4
No	Ramp Width (in)	47.0	No	Ramp XSlope (%)	2.5
N/A	Flare Type LT	N/A	N/A	Flare Type RT	N/A
N/A	Flare Slope LT (%)	N/A	N/A	Flare Slope RT (%)	N/A
N/A	Flare Traversable LT?	N/A	N/A	Flare Traversable RT?	N/A
N/A	Landing Length (in)	N/A	N/A	DWS Provided?	N/A
N/A	Landing Width (in)	N/A	N/A	DWS Contrast?	N/A
N/A	Landing Slope (%)	N/A	N/A	DWS Length (in)	N/A
N/A	Landing X Slope (%)	N/A	N/A	DWS Full Width?	N/A
N/A	Landing Curb? (Y/N)	N/A	N/A	DWS Offset (in)	N/A
N/A	Shared Landing?	N/A			
N/A	Gutter Ponding?	N/A	N/A	Gutter Slope (%)	N/A
N/A	Gutter Lip Ht (in)	N/A	N/A	Gutter X Slope (%)	N/A
N/A	Painted X Walk1?	No	N/A	Painted X Walk2?	N/A
	X Walk 1 Direction	To S		X Walk 2 Direction	N/A
N/A	X Walk 1 Width (in)	N/A	N/A	X Walk 2 Width (in)	N/A
	X Walk 1 Slope (%)	4.5		X Walk 2 Slope (%)	N/A
	X Walk 1 X Slope (%)	3.5		X Walk 2 X Slope (%)	N/A

N/A	Ramp inside XWalk1?	N/A	N/A	Ramp inside XWalk2?	N/A
	Road Slope (%)	3.5	N/A	Clear Space?	N/A
	Road X Slope (%)	4.5	N/A	Clear Space to XWalk (in)	N/A
N/A	Any Obstructions?	N/A	N/A	Storm Grate/Utility Hazard?	N/A
	Obstruction Type			Storm Grate/Utility Type	
		N/A			N/A
			Yes	Surface Condition? (G/P)	Good

Possible Solutions:									
	Remove & Replace Entire Ramp.									
	Surveyor Notes:									
	N/A									
	PROW/ADA:									
	Not Found, R304.5.1, R304.5.3									
	Street 1 Name		WASHINGTON AV							
	Stop Condition-Street 2		StopSign							
	Street 2 Name		N/A							
	Stop Condition-Street 1		N/A							
Total Cost:		\$ 1850.00
