Access Compliance Report Public Rights-of-Way (Curb Ramps)

Intersection ID: 19263 Main Street: VILLAGE LAKE DR **Cross Street: CREEKRIDGE RD** Location: SW ADA ID: BE4C6112825A Ramp Type: PerpDiag Initial Pass/Fail: Fail **Overall Compliance: No Severity Score:** 22.5

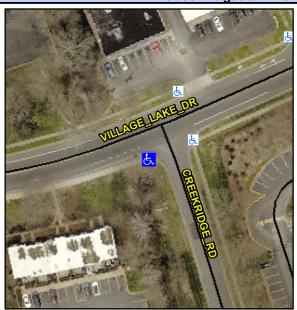
Field Measurements/Component Compliance					
Compliance Description		Data	Comp	liance Description	Data
N/A	Ramp Length (in)	83.0	No	Ramp Slope (%)	8.8
No	Ramp Width (in)	47.5	No	Ramp XSlope (%)	3.5
N/A	Flare Type LT	N/A	N/A	Flare Type RT	N/A
N/A	Flare Slope LT (%)	N/A	N/A	Flare Slope RT (%)	N/A
N/A	Flare Traversable LT?	N/A	N/A	Flare Traversable RT?	N/A
N/A	Landing Length (in)	N/A	N/A	DWS Provided?	N/A
N/A	Landing Width (in)	N/A	N/A	DWS Contrast?	N/A
N/A	Landing Slope (%)	N/A	N/A	DWS Length (in)	N/A
N/A	Landing X Slope (%)	N/A	N/A	DWS Full Width?	N/A
N/A	Landing Curb? (Y/N)	N/A	N/A	DWS Offset (in)	N/A
N/A	Shared Landing?	N/A			
N/A	Gutter Ponding?	N/A	N/A	Gutter Slope (%)	N/A
N/A	Gutter Lip Ht (in)	N/A	N/A	Gutter X Slope (%)	N/A
N/A	Painted X Walk1?	No	N/A	Painted X Walk2?	No
	X Walk 1 Direction	То Е		X Walk 2 Direction	To N
N/A	X Walk 1 Width (in)	N/A	N/A	X Walk 2 Width (in)	N/A
	X Walk 1 Slope (%)	2.6		X Walk 2 Slope (%)	7.9

X Walk 1 X Slope (%)	5.8		X Walk 2 X Slope (%)	3.3
N/A	Ramp inside XWalk1?	N/A	N/A	Ramp inside XWalk2?	N/A
	Road Slope (%)	1.4	N/A	Clear Space?	N/A
	Road X Slope (%)	9.0	N/A	Clear Space to XWalk (in)	N/A
N/A	Any Obstructions?	N/A	N/A	Storm Grate/Utility Hazard?	N/A
	Obstruction Type			Storm Grate/Utility Type	
		N/A			N/A
			Yes	Surface Condition? (G/P)	Good
	The state of the s

Possible Solutions: Remove & Replace Curb Ramp With **Two New Directional Ramps or** Equivalent. Surveyor Notes: N/A PROW/ADA: Not Found, R304.5.1, R304.2.2, R304.5.3
