Access Compliance Report

Public Rights-of-Way

(Curb Ramps)

| Intersection ID: 45160 | Main Street: REID_BROOK_LN | Cross Street: REID_OAKS_DR | Location: S |

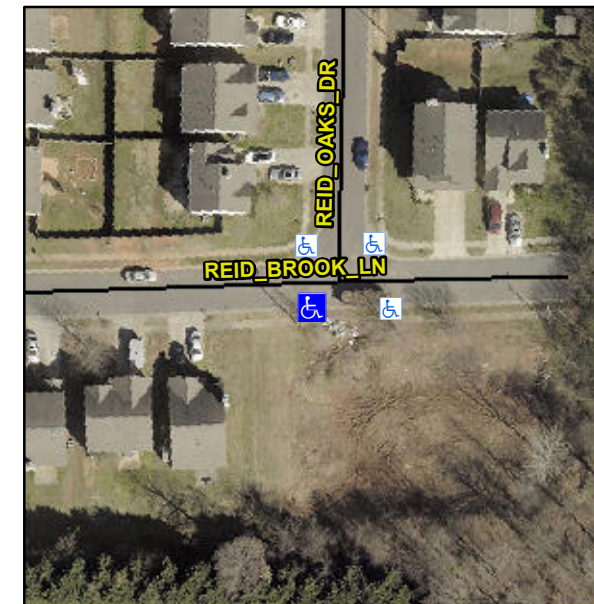
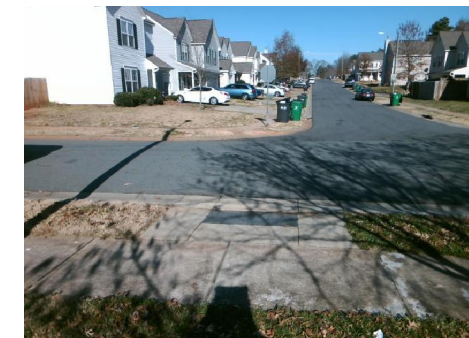
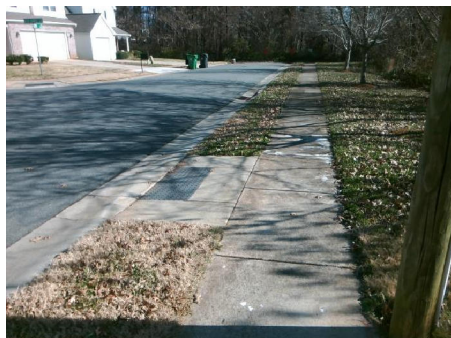
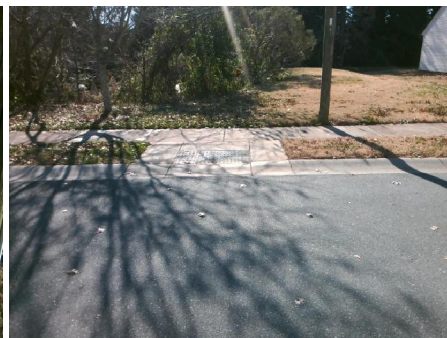
| ADA ID: BE55F1484D41 | Ramp Type: Perp | Initial Pass/Fail: Fail | Overall Compliance: No |
| | | Severity Score: 8.75 | |

Not Found, R304.5.1

| Compliance | Description | Data | Compliance | Description | Data |
|---|---|---|---|---|---|
| No | Ramp Width (in) | 47.5 | Yes | Ramp XSlope (%) | 0.2 |

Remove & Replace Entire Ramp.

Total Cost: \$ 1850.00
