# Access Compliance Report

## Public Rights-of-Way

### (Curb Ramps)

| Intersection ID: 30314 | Main Street: ROCKET_LN | Cross Street: SHINKANSEN_DR | Location: S |

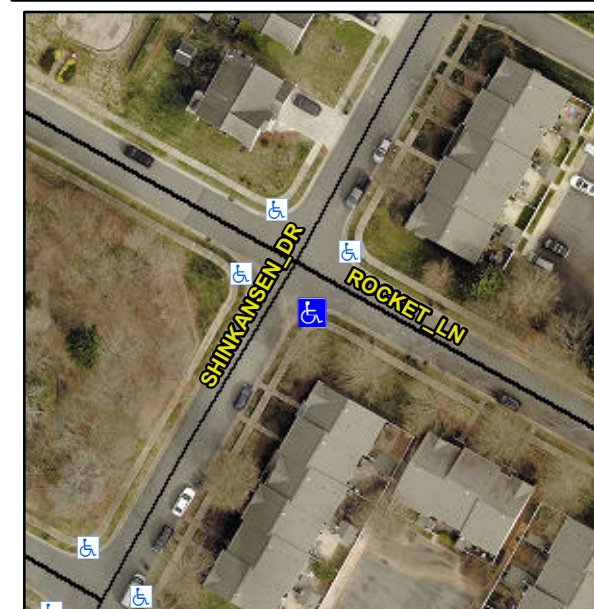
**RP < 5%, LNDG GAP 1.0**

**Not Found, R304.5.1**

**Remove & Replace Curb Ramp With Two New Directional Ramps or Equivalent.**

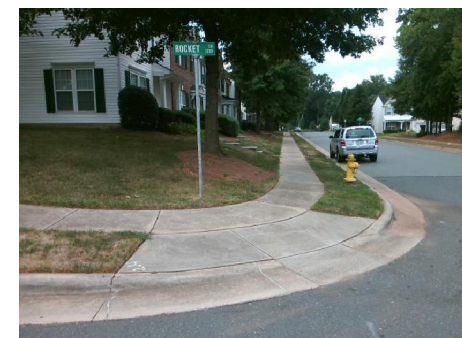
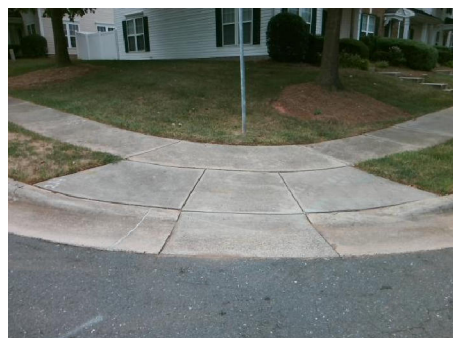
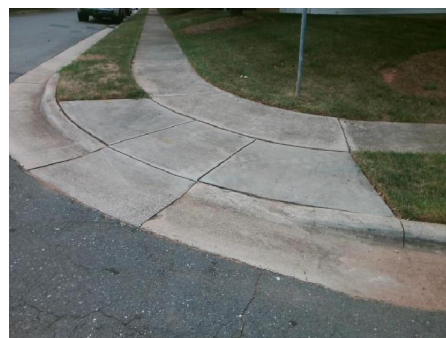
| Compliance | Description | Data | Compliance | Description | Data |
|---|---|---|---|---|---|
| No | Ramp Width (in) | 36.5 | Yes | BlendTrans XSlope (%) | 1.3 |
| | | | No | Curb Slope (%) | 25.2 |
