Access Compliance Report

Public Rights-of-Way

(Curb Ramps)

Intersection ID: 4122	Main Street: DAVID_COX_RD	Cross Street: MALLARD_RIDGE_DR	Location: NE
ADA ID: BE68D1D83C19	Ramp Type: PerpDiag	Initial Pass/Fail: Fail	Overall Compliance: No
		Severity Score: 35

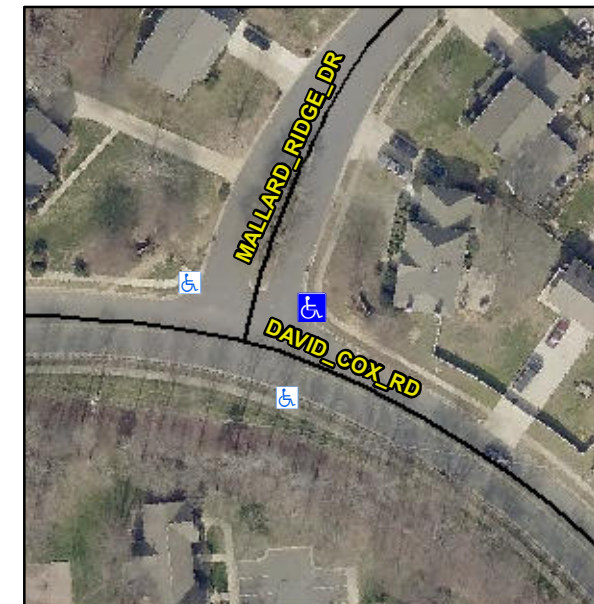
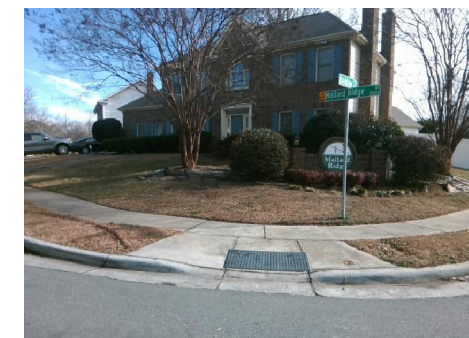
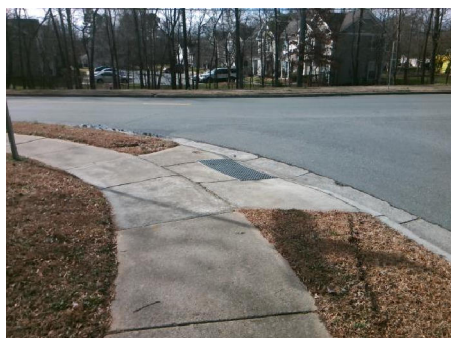
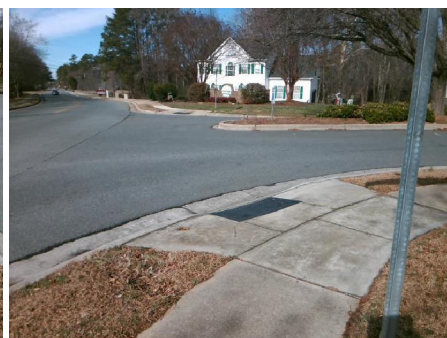
Not Found, R304.5.1, R304.2.2, R304.5.3

Compliance	Description	Data	Compliance	Description	Data
N/A	Ramp Length (in)	50.0	No	Ramp Slope (%)	14.2
No	Ramp Width (in)	40.0	No	Ramp XSlope (%)	3.4
N/A	Flare Type LT	N/A	N/A	Flare Type RT	N/A
N/A	Flare Slope LT (%)	N/A	N/A	Flare Slope RT (%)	N/A
N/A	Flare Traversable LT?	N/A	N/A	Flare Traversable RT?	N/A
N/A	Landing Length (in)	N/A	N/A	DWS Provided?	N/A
N/A	Landing Width (in)	N/A	N/A	DWS Contrast?	N/A
N/A	Landing Slope (%)	N/A	N/A	DWS Length (in)	N/A
N/A	Landing X Slope (%)	N/A	N/A	DWS Full Width?	N/A
N/A	Landing Curb? (Y/N)	N/A	N/A	DWS Offset (in)	N/A
N/A	Shared Landing?	N/A			
N/A	Gutter Ponding?	N/A	N/A	Gutter Slope (%)	N/A
N/A	Gutter Lip Ht (in)	N/A	N/A	Gutter X Slope (%)	N/A
N/A	Painted X Walk1?	No	N/A	Painted X Walk2?	No
	X Walk 1 Direction	To W		X Walk 2 Direction	To S
N/A	X Walk 1 Width (in)	N/A	N/A	X Walk 2 Width (in)	N/A
	X Walk 1 Slope (%)	5.4		X Walk 2 Slope (%)	1.9
	X Walk 1 X Slope (%)	1.3		X Walk 2 X Slope (%)	2.9

N/A	Ramp inside XWalk1?	N/A	N/A	Ramp inside XWalk2?	N/A
	Road Slope (%)	3.3	N/A	Clear Space?	N/A
	Road X Slope (%)	3.0	N/A	Clear Space to XWalk (in)	N/A
N/A	Any Obstructions?	N/A	N/A	Storm Grate/Utility Hazard?	N/A
	Obstruction Type			Storm Grate/Utility Type	
		N/A			N/A
			Yes	Surface Condition? (G/P)	Good

Remove & Replace Curb Ramp With Two New Directional Ramps or Equivalent.
