Access Compliance Report

Public Rights-of-Way

(Curb Ramps)

Intersection ID: 30498	Main Street: BEDDINGFIELD_DR	Cross Street: ORCHARD GRASS_CT	Location: W
ADA ID: BE74ADF0E76E	Ramp Type: PerpDiag	Initial Pass/Fail: Fail	Overall Compliance: No
Severity Score: 8.75			
Codes/Mitigation Info/Possible Solution		Field Measurements/Component Compliance

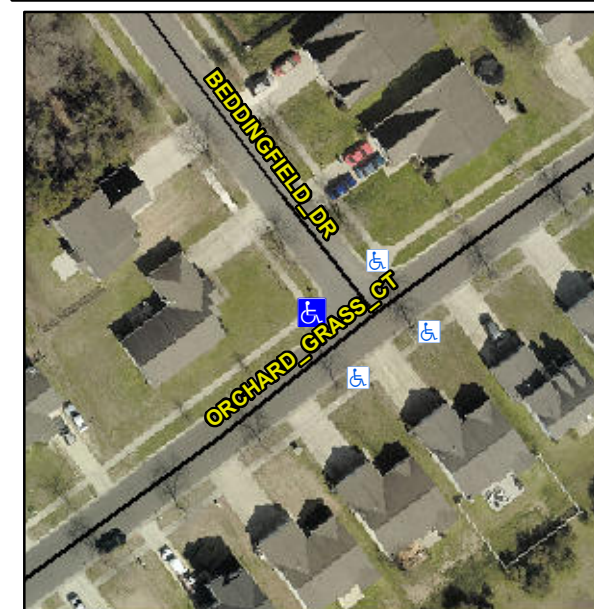
Compliance	Description	Data	Compliance	Description	Data
N/A	Ramp Length (in)	83.0	Yes	Ramp Slope (%)	5.0
No	Ramp Width (in)	42.5	Yes	Ramp XSlope (%)	1.2
N/A	Flare Type LT	N/A	N/A	Flare Type RT	N/A
N/A	Flare Slope LT (%)	N/A	N/A	Flare Slope RT (%)	N/A
N/A	Flare Traversable LT?	N/A	N/A	Flare Traversable RT?	N/A
N/A	Landing Length (in)	N/A	N/A	DWS Provided?	N/A
N/A	Landing Width (in)	N/A	N/A	DWS Contrast?	N/A
N/A	Landing Slope (%)	N/A	N/A	DWS Length (in)	N/A
N/A	Landing X Slope (%)	N/A	N/A	DWS Full Width?	N/A
N/A	Landing Curb? (Y/N)	N/A	N/A	DWS Offset (in)	N/A
N/A	Shared Landing?	N/A			
N/A	Gutter Ponding?	N/A	N/A	Gutter Slope (%)	N/A
N/A	Gutter Lip Ht (in)	N/A	N/A	Gutter X Slope (%)	N/A
N/A	Painted X Walk1?	No	N/A	Painted X Walk2?	No
	X Walk 1 Direction	To SE		X Walk 2 Direction	To NE
N/A	X Walk 1 Width (in)	N/A	N/A	X Walk 2 Width (in)	N/A
	X Walk 1 Slope (%)	1.2		X Walk 2 Slope (%)	1.0
	X Walk 1 X Slope (%)	0.9		X Walk 2 X Slope (%)	1.2

N/A	Ramp inside XWalk1?	N/A	N/A	Ramp inside XWalk2?	N/A
	Road Slope (%)	0.8	N/A	Clear Space?	N/A
	Road X Slope (%)	3.4	N/A	Clear Space to XWalk (in)	N/A
N/A	Any Obstructions?	N/A	N/A	Storm Grate/Utility Hazard?	N/A
	Obstruction Type			Storm Grate/Utility Type	
		N/A			N/A
			Yes	Surface Condition? (G/P)	Good

Possible Solutions:

Remove & Replace Curb Ramp With Two New Directional Ramps or Equivalent.

R304.5.1
