Access Compliance Report

Public Rights-of-Way

(Curb Ramps)

Intersection ID: 3215	Main Street: BELLMORE_CT	Cross Street: OLD_BRIDGE_LN	Location: SW
ADA ID: BE7BEE09D814	Ramp Type: Perp	Initial Pass/Fail: Fail	Overall Compliance: No
Severity Score: 37.5			
Codes/Mitigation Info/Possible Solution		Field Measurements/Component Compliance

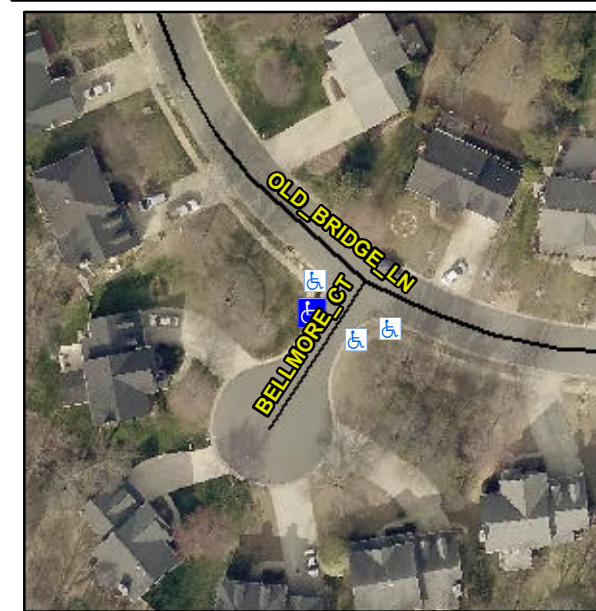
Not Found, R304.2.2, R304.5.3

Compliance	Description	Data	Compliance	Description	Data
N/A	Ramp Length (in)	45.0	No	Ramp Slope (%)	13.1
Yes	Ramp Width (in)	48.0	No	Ramp XSlope (%)	5.3
N/A	Flare Type LT	N/A	N/A	Flare Type RT	N/A
N/A	Flare Slope LT (%)	N/A	N/A	Flare Slope RT (%)	N/A
N/A	Flare Traversable LT?	N/A	N/A	Flare Traversable RT?	N/A
N/A	Landing Length (in)	N/A	N/A	DWS Provided?	N/A
N/A	Landing Width (in)	N/A	N/A	DWS Contrast?	N/A
N/A	Landing Slope (%)	N/A	N/A	DWS Length (in)	N/A
N/A	Landing X Slope (%)	N/A	N/A	DWS Full Width?	N/A
N/A	Landing Curb? (Y/N)	N/A	N/A	DWS Offset (in)	N/A
N/A	Shared Landing?	N/A			
N/A	Gutter Ponding?	N/A	N/A	Gutter Slope (%)	N/A
N/A	Gutter Lip Ht (in)	N/A	N/A	Gutter X Slope (%)	N/A
N/A	Painted X Walk1?	No	N/A	Painted X Walk2?	N/A
	X Walk 1 Direction	To SE		X Walk 2 Direction	N/A
N/A	X Walk 1 Width (in)	N/A	N/A	X Walk 2 Width (in)	N/A
	X Walk 1 Slope (%)	0.7		X Walk 2 Slope (%)	N/A
	X Walk 1 X Slope (%)	3.5		X Walk 2 X Slope (%)	N/A

N/A	Ramp inside XWalk1?	N/A	N/A	Ramp inside XWalk2?	N/A
	Road Slope (%)	N/A	N/A	Clear Space?	N/A
	Road X Slope (%)	N/A	N/A	Clear Space to XWalk (in)	N/A
N/A	Any Obstructions?	N/A	N/A	Storm Grate/Utility Hazard?	N/A
	Obstruction Type			Storm Grate/Utility Type	
		N/A			N/A
			Yes	Surface Condition? (G/P)	Good

Remove & Replace Entire Ramp.

Total Cost: \$ 1850.00
