Access Compliance Report

Public Rights-of-Way

(Curb Ramps)

Intersection ID: 47276	Main Street: CARRINGTON_FOREST_LN	Cross Street: MCKEE_RD	Location: SW
ADA ID: BE80AE180EE2	Ramp Type: Perp	Initial Pass/Fail: Fail	Overall Compliance: No
Severity Score: 10			
Codes/Mitigation Info/Possible Solution		Field Measurements/Component Compliance

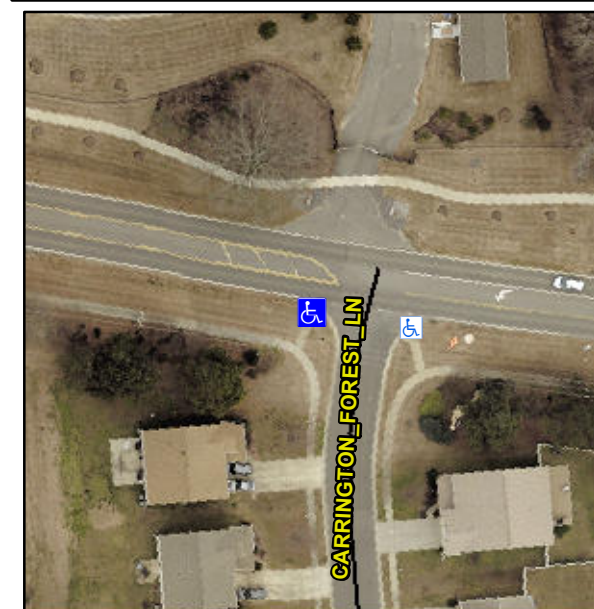
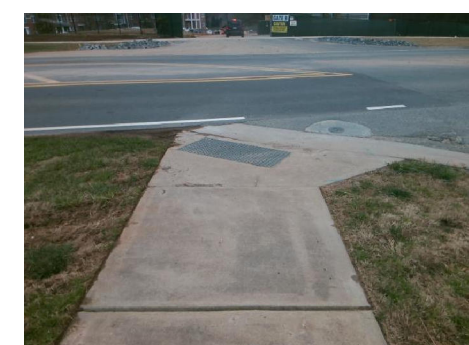
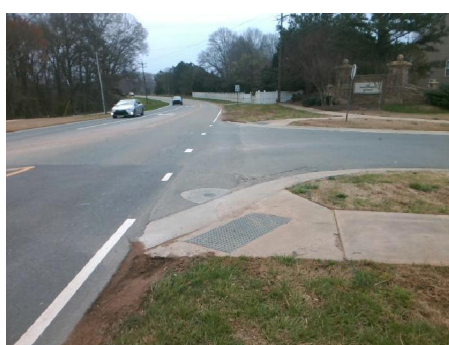
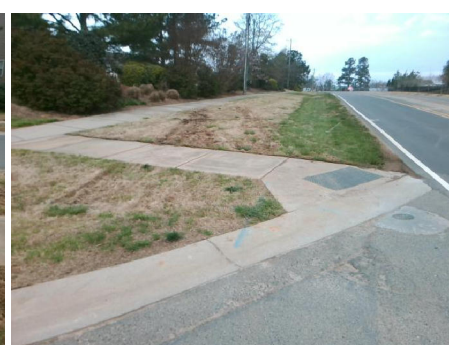
R304.5.1, R304.5.3

Compliance	Description	Data	Compliance	Description	Data
N/A	Ramp Length (in)	36.0	Yes	Ramp Slope (%)	6.2
No	Ramp Width (in)	45.0	No	Ramp XSlope (%)	3.1
N/A	Flare Type LT	N/A	N/A	Flare Type RT	N/A
N/A	Flare Slope LT (%)	N/A	N/A	Flare Slope RT (%)	N/A
N/A	Flare Traversable LT?	N/A	N/A	Flare Traversable RT?	N/A
N/A	Landing Length (in)	N/A	N/A	DWS Provided?	N/A
N/A	Landing Width (in)	N/A	N/A	DWS Contrast?	N/A
N/A	Landing Slope (%)	N/A	N/A	DWS Length (in)	N/A
N/A	Landing X Slope (%)	N/A	N/A	DWS Full Width?	N/A
N/A	Landing Curb? (Y/N)	N/A	N/A	DWS Offset (in)	N/A
N/A	Shared Landing?	N/A			
N/A	Gutter Ponding?	N/A	N/A	Gutter Slope (%)	N/A
N/A	Gutter Lip Ht (in)	N/A	N/A	Gutter X Slope (%)	N/A
N/A	Painted X Walk1?	No	N/A	Painted X Walk2?	N/A
	X Walk 1 Direction	To E		X Walk 2 Direction	N/A
N/A	X Walk 1 Width (in)	N/A	N/A	X Walk 2 Width (in)	N/A
	X Walk 1 Slope (%)	2.1		X Walk 2 Slope (%)	N/A
	X Walk 1 X Slope (%)	3.2		X Walk 2 X Slope (%)	N/A

N/A	Ramp inside XWalk1?	N/A	N/A	Ramp inside XWalk2?	N/A
	Road Slope (%)	N/A	N/A	Clear Space?	N/A
	Road X Slope (%)	N/A	N/A	Clear Space to XWalk (in)	N/A
N/A	Any Obstructions?	N/A	N/A	Storm Grate/Utility Hazard?	N/A
	Obstruction Type			Storm Grate/Utility Type	
		N/A			N/A
		Yes		Surface Condition? (G/P)	Good

Possible Solutions:

Remove & Replace Entire Ramp.

Total Cost: \$ 1850.00
