# Access Compliance Report

## Public Rights-of-Way

### (Curb Ramps)

Intersection ID: 3740	Main Street: CHESTNUT_KNOLL_LN	Cross Street: DAVIS_LAKE_PY	Location: W
ADA ID: BE87098B3181	Ramp Type: Perp	Initial Pass/Fail: Fail	Overall Compliance: No
Severity Score: 26.25			
Codes/Mitigation Info/Possible Solution		Field Measurements/Component Compliance

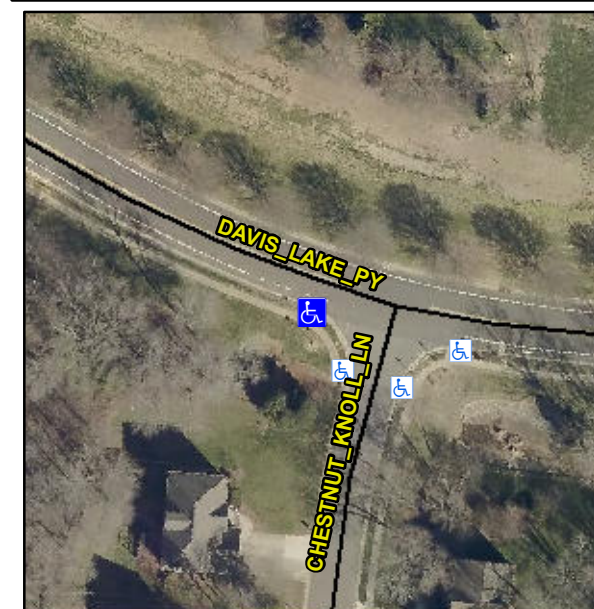
**Not Found, R304.2.2, R304.5.3**

Compliance	Description	Data	Compliance	Description	Data
N/A	Ramp Length (in)	48.0	No	Ramp Slope (%)	18.5
Yes	Ramp Width (in)	48.0	No	Ramp XSlope (%)	2.5
N/A	Flare Type LT	N/A	N/A	Flare Type RT	N/A
N/A	Flare Slope LT (%)	N/A	N/A	Flare Slope RT (%)	N/A
N/A	Flare Traversable LT?	N/A	N/A	Flare Traversable RT?	N/A
N/A	Landing Length (in)	N/A	N/A	DWS Provided?	N/A
N/A	Landing Width (in)	N/A	N/A	DWS Contrast?	N/A
N/A	Landing Slope (%)	N/A	N/A	DWS Length (in)	N/A
N/A	Landing X Slope (%)	N/A	N/A	DWS Full Width?	N/A
N/A	Landing Curb? (Y/N)	N/A	N/A	DWS Offset (in)	N/A
N/A	Shared Landing?	N/A			
N/A	Gutter Ponding?	N/A	N/A	Gutter Slope (%)	N/A
N/A	Gutter Lip Ht (in)	N/A	N/A	Gutter X Slope (%)	N/A
N/A	Painted X Walk1?	No	N/A	Painted X Walk2?	N/A
	X Walk 1 Direction	To NE		X Walk 2 Direction	N/A
N/A	X Walk 1 Width (in)	N/A	N/A	X Walk 2 Width (in)	N/A
	X Walk 1 Slope (%)	4.6		X Walk 2 Slope (%)	N/A
	X Walk 1 X Slope (%)	0.1		X Walk 2 X Slope (%)	N/A

N/A	Ramp inside XWalk1?	N/A	N/A	Ramp inside XWalk2?	N/A
	Road Slope (%)	N/A	N/A	Clear Space?	N/A
	Road X Slope (%)	N/A	N/A	Clear Space to XWalk (in)	N/A
N/A	Any Obstructions?	N/A	N/A	Storm Grate/Utility Hazard?	N/A
	Obstruction Type			Storm Grate/Utility Type	
		N/A			N/A
		Yes		Surface Condition? (G/P)	Good

Possible Solutions:

**Remove & Replace Entire Ramp.**

Total Cost: \$ 1850.00
