# Access Compliance Report

## Public Rights-of-Way

### (Curb Ramps)

| Intersection ID: N/A | Main Street: ELLIOTT_ST | Cross Street: N_I-77_EXIT_10A_RA | Location: NW |

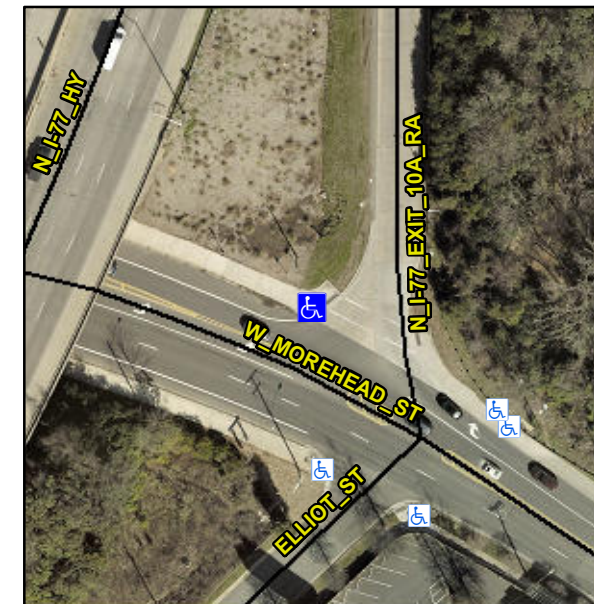
**LT RP < 5%**

**R304.5.3, R304.2.1, R305.2**

| Compliance | Description | Data | Compliance | Description | Data |
|---|---|---|---|---|---|
| No | Ramp XSlope LT (%) | 3.2 | N/A | Ramp XSlope RT (%) | N/A |
| No | Landing Length (in) | 56.0 | Yes | DWS Provided? | Yes |
| N/A | Landing Curb? (Y/N) | Yes | No | DWS Offset (in) | 4.0 |

**Remove & Replace Entire Ramp.  
Remove & Replace Sidewalk.**
