Access Compliance Report

Public Rights-of-Way

(Curb Ramps)

Intersection ID: 53980	Main Street: ABENDEGO_RD	Cross Street: SUNBURST_LN	Location: S
ADA ID: BEA3BA994585	Ramp Type: BlendTrans1	Initial Pass/Fail: Fail	Overall Compliance: No
Severity Score: 8.75			
Codes/Mitigation Info/Possible Solution		Field Measurements/Component Compliance

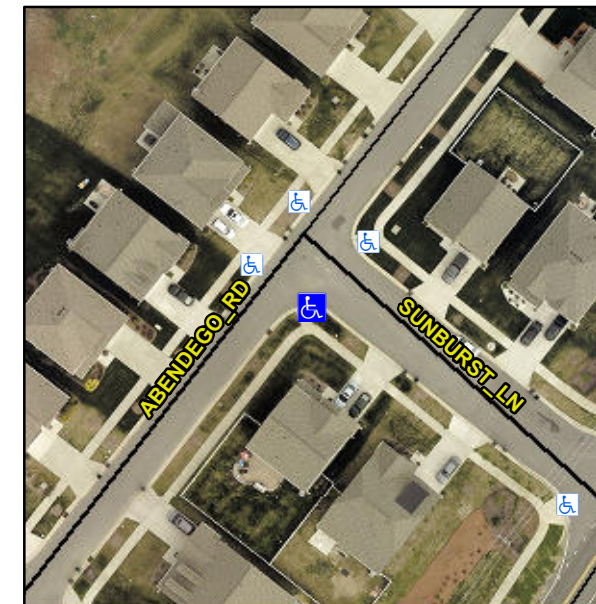
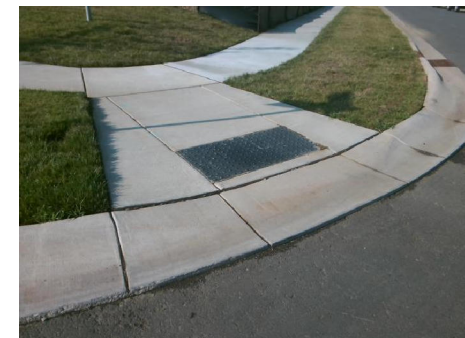
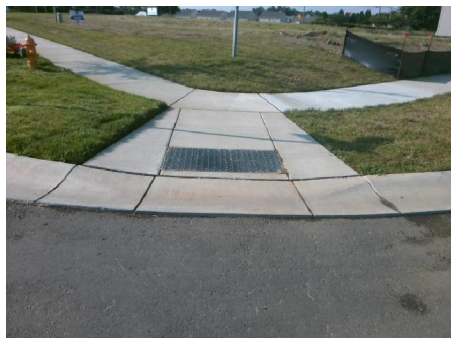
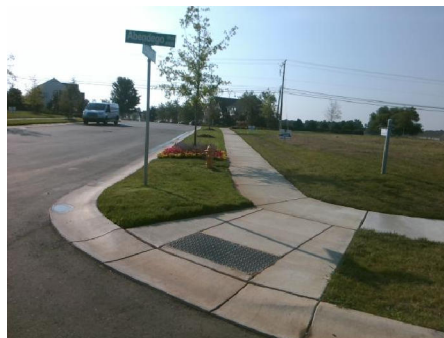
Compliance	Description	Data	Compliance	Description	Data
N/A	Ramp Length (in)	97.0	Yes	BlendTrans Slope (%)	4.3
No	Ramp Width (in)	47.5	Yes	BlendTrans XSlope (%)	2.0
N/A	Flare Type LT	N/A	N/A	Flare Type RT	N/A
N/A	Flare Slope LT (%)	N/A	N/A	Flare Slope RT (%)	N/A
N/A	Flare Traversable LT?	N/A	N/A	Flare Traversable RT?	N/A
N/A	Landing Length (in)	N/A	N/A	DWS Provided?	N/A
N/A	Landing Width (in)	N/A	N/A	DWS Contrast?	N/A
N/A	Landing Slope (%)	N/A	N/A	DWS Length (in)	N/A
N/A	Landing X Slope (%)	N/A	N/A	DWS Full Width?	N/A
N/A	Landing Curb? (Y/N)	N/A	N/A	DWS Offset (in)	N/A
N/A	Shared Landing?	N/A			
N/A	Gutter Ponding?	N/A	N/A	Gutter Slope (%)	N/A
N/A	Gutter Lip Ht (in)	N/A	N/A	Gutter X Slope (%)	N/A
N/A	Painted X Walk1?	No	N/A	Painted X Walk2?	No
	X Walk 1 Direction	To E		X Walk 2 Direction	To W
	X Walk 1 Width (in)	N/A		X Walk 2 Width (in)	N/A
	X Walk 1 Slope (%)	1.7		X Walk 2 Slope (%)	1.8
	X Walk 1 X Slope (%)	1.8		X Walk 2 X Slope (%)	0.4

N/A	Ramp inside XWalk1?	N/A	N/A	Ramp inside XWalk2?	N/A
	Road Slope (%)	1.0		Clear Space?	N/A
	Road X Slope (%)	2.6	N/A	Clear Space to XWalk (in)	N/A
N/A	Any Obstructions?	N/A	N/A	Storm Grate/Utility Hazard?	N/A
	Obstruction Type			Storm Grate/Utility Type	
		N/A			N/A
			Yes	Surface Condition? (G/P)	Good
			N/A	Curb Slope (%)	N/A

Remove & Replace Curb Ramp With Two New Directional Ramps or Equivalent.

R304.5.1
