Access Compliance Report

Public Rights-of-Way

(Curb Ramps)

Intersection ID: 12488	Main Street: DEHERRADORA_AV	Cross Street: WILKINSON_BV	Location: NE
ADA ID: BEAF06C87EFC	Ramp Type: Perp	Initial Pass/Fail: Fail	Overall Compliance: No
			Severity Score: 13.75

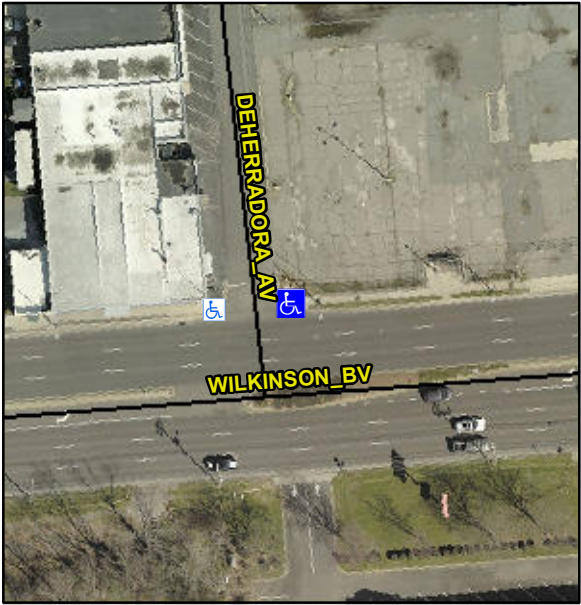
Possible Solutions:		Compliance	Description	Data
	Remove & Replace Entire Ramp.		No	Ramp Length (in)	59.0
			Yes	Ramp Width (in)	50.0
			N/A	Flare Type LT	N/A
			N/A	Flare Slope LT (%)	N/A
			N/A	Flare Traversable LT?	N/A
			N/A	Landing Length (in)	N/A
			N/A	Landing Width (in)	N/A
			N/A	Landing Slope (%)	N/A
			N/A	Landing X Slope (%)	N/A
<p>Surveyor Notes:</p> <p>N/A</p> <p>PROW/ADA:</p> <p>Not Found, R304.2.2, R304.5.3</p>			N/A	Flare Type RT	N/A
			N/A	Flare Slope RT (%)	N/A
			N/A	Flare Traversable RT?	N/A
			N/A	DWS Provided?	N/A
			N/A	DWS Contrast?	N/A
			N/A	DWS Length (in)	N/A
			N/A	DWS Full Width?	N/A
			N/A	DWS Offset (in)	N/A
			N/A	Gutter Ponding?	N/A
			N/A	Gutter Lip Ht (in)	N/A
<p>Total Cost:</p> <p>\$ 1850.00</p>			No	Painted X Walk1?	N/A
			To W	X Walk 2 Direction	N/A
			N/A	X Walk 2 Width (in)	N/A

0.5	X Walk 2 Slope (%)	N/A
			1.3	X Walk 2 X Slope (%)	N/A
			N/A	Ramp inside XWalk1?	N/A
			N/A	Ramp inside XWalk2?	N/A
			N/A	Clear Space?	N/A
			N/A	Clear Space to XWalk (in)	N/A
			N/A	Storm Grate/Utility Hazard?	N/A
<p>Obstruction Type</p> <p>N/A</p>			N/A	Storm Grate/Utility Type	N/A
			N/A	Surface Condition? (G/P)	Good
