# Access Compliance Report

## Public Rights-of-Way

Intersection ID: 49126	Main Street: CARLOTA_CT	Cross Street: LEGOLAS_LN	Location: SW
ADA ID: BEB61DF81EE0	Ramp Type: PerpDiag	Initial Pass/Fail: Fail	Overall Compliance: No
		Severity Score: 10

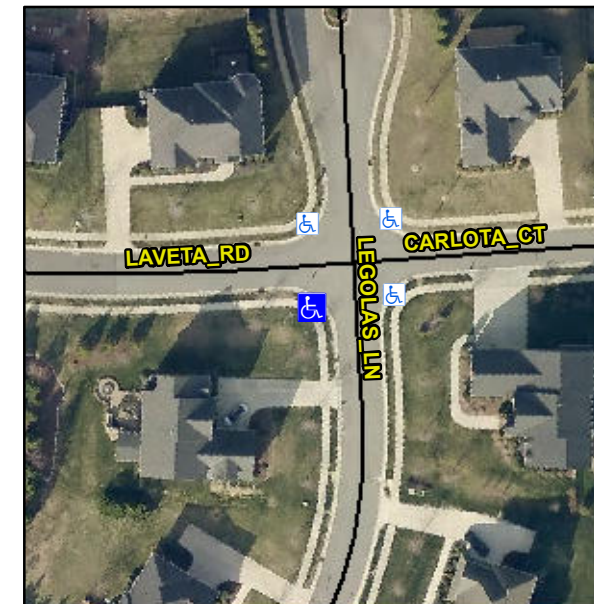
**Not Found, R304.5.1, R304.5.3**

Compliance	Description	Data	Compliance	Description	Data
N/A	Ramp Length (in)	48.0	Yes	Ramp Slope (%)	7.2
No	Ramp Width (in)	46.0	No	Ramp XSlope (%)	2.6
N/A	Flare Type LT	N/A	N/A	Flare Type RT	N/A
N/A	Flare Slope LT (%)	N/A	N/A	Flare Slope RT (%)	N/A
N/A	Flare Traversable LT?	N/A	N/A	Flare Traversable RT?	N/A
N/A	Landing Length (in)	N/A	N/A	DWS Provided?	N/A
N/A	Landing Width (in)	N/A	N/A	DWS Contrast?	N/A
N/A	Landing Slope (%)	N/A	N/A	DWS Length (in)	N/A
N/A	Landing X Slope (%)	N/A	N/A	DWS Full Width?	N/A
N/A	Landing Curb? (Y/N)	N/A	N/A	DWS Offset (in)	N/A
N/A	Shared Landing?	N/A			
N/A	Gutter Ponding?	N/A	N/A	Gutter Slope (%)	N/A
N/A	Gutter Lip Ht (in)	N/A	N/A	Gutter X Slope (%)	N/A
N/A	Painted X Walk1?	No	N/A	Painted X Walk2?	No
	X Walk 1 Direction	To E		X Walk 2 Direction	To N
N/A	X Walk 1 Width (in)	N/A	N/A	X Walk 2 Width (in)	N/A
	X Walk 1 Slope (%)	0.1		X Walk 2 Slope (%)	0.2
	X Walk 1 X Slope (%)	3.2		X Walk 2 X Slope (%)	3.8

N/A	Ramp inside XWalk1?	N/A	N/A	Ramp inside XWalk2?	N/A
	Road Slope (%)	2.6	N/A	Clear Space?	N/A
	Road X Slope (%)	3.2	N/A	Clear Space to XWalk (in)	N/A
N/A	Any Obstructions?	N/A	N/A	Storm Grate/Utility Hazard?	N/A
	Obstruction Type			Storm Grate/Utility Type	
		N/A			N/A
			Yes	Surface Condition? (G/P)	Good

**Remove & Replace Curb Ramp With Two New Directional Ramps or Equivalent.**
