Access Compliance Report

Public Rights-of-Way

(Curb Ramps)

Intersection ID: 10032566	Main Street: N_GRAHAM_ST	Cross Street: N/A	Location: W
ADA ID: BEC62A513C07	Ramp Type: Directional2	Initial Pass/Fail: Fail	Overall Compliance: No
Severity Score: 13.75			
Codes/Mitigation Info/Possible Solution		Field Measurements/Component Compliance

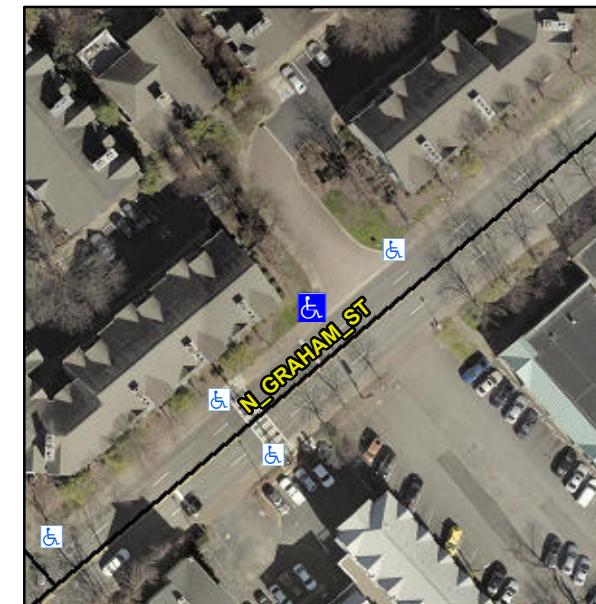
PONDING

R304.2.2, R304.5.3

Compliance	Description	Data	Compliance	Description	Data
N/A	Ramp Length (in)	67.0	N/A	Grade Break?	N/A
Yes	Ramp Width (in)	61.0	N/A	Grade Break Slope (%)	0.0
No	Ramp Slope (%)	9.1	N/A	Grade Break XSlope (%)	0.0
No	Ramp XSlope (%)	3.6			
N/A	Flare Type LT	N/A	N/A	Flare Type RT	N/A
N/A	Flare Slope LT (%)	N/A	N/A	Flare Slope RT (%)	0.0
N/A	Flare Traversable LT?	N/A	N/A	Flare Traversable RT?	N/A
N/A	Landing Length (in)	0.0	N/A	DWS Provided?	N/A
N/A	Landing Width (in)	0.0	N/A	DWS Contrast?	N/A
N/A	Landing Slope (%)	0.0	N/A	DWS Length (in)	N/A
N/A	Landing X Slope (%)	0.0	N/A	DWS Full Width?	N/A
N/A	Landing Curb? (Y/N)	N/A	N/A	DWS Offset LT (in)	N/A
N/A	Shared Landing?	N/A	N/A	DWS Offset RT (in)	N/A
N/A	Gutter Ponding?	0.0	N/A	Gutter Slope (%)	N/A
N/A	Gutter Lip Ht (in)	0.0	N/A	Gutter X Slope (%)	N/A
N/A	Painted X Walk1?	No		Road Slope (%)	1.1
	X Walk 1 Direction	To NE		Road X Slope (%)	0.5
	X Walk 1 Width (in)	N/A		Clear Space?	N/A

X Walk 1 Slope (%)	1.1	N/A	Clear Space to XWalk (in)	N/A
	X Walk 1 X Slope (%)	0.5	N/A	Storm Grate/Utility Hazard?	N/A
N/A	Ramp inside XWalk1?	N/A		Storm Grate/Utility Type	
N/A	Any Obstructions?	N/A			N/A
	Obstruction Type		Yes	Surface Condition? (G/P)	Good
			N/A	Curb Slope (%)	0.4

Remove & Replace Entire Ramp.
