Access Compliance Report

Public Rights-of-Way

(Curb Ramps)

Intersection ID: 3083	Main Street: LOGANVILLE_DR	Cross Street: PANTHERSVILLE_DR	Location: NW
ADA ID: BED071DA5898	Ramp Type: Perp	Initial Pass/Fail: Fail	Overall Compliance: No
Codes/Mitigation Info/Possible Solution		Field Measurements/Component Compliance	
Severity Score: 36.25

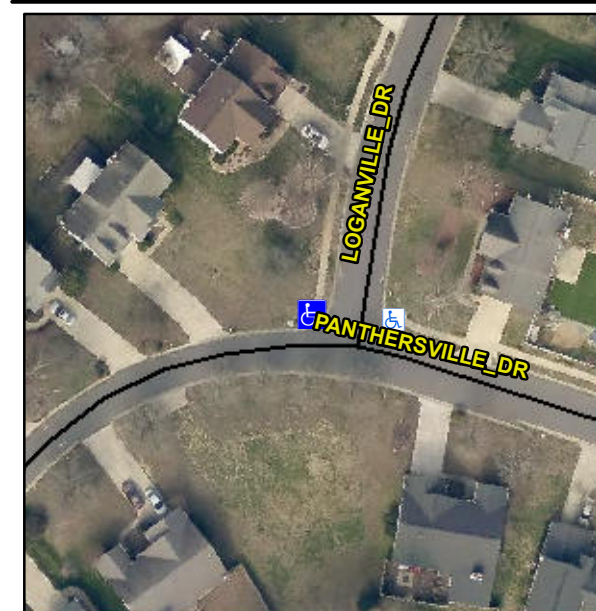
Not Found, R304.5.1, R304.5.3

Compliance	Description	Data	Compliance	Description	Data
N/A	Ramp Length (in)	97.5	Yes	Ramp Slope (%)	5.7
No	Ramp Width (in)	26.5	No	Ramp XSlope (%)	2.5
N/A	Flare Type LT	N/A	N/A	Flare Type RT	N/A
N/A	Flare Slope LT (%)	N/A	N/A	Flare Slope RT (%)	N/A
N/A	Flare Traversable LT?	N/A	N/A	Flare Traversable RT?	N/A
N/A	Landing Length (in)	N/A	N/A	DWS Provided?	N/A
N/A	Landing Width (in)	N/A	N/A	DWS Contrast?	N/A
N/A	Landing Slope (%)	N/A	N/A	DWS Length (in)	N/A
N/A	Landing X Slope (%)	N/A	N/A	DWS Full Width?	N/A
N/A	Landing Curb? (Y/N)	N/A	N/A	DWS Offset (in)	N/A
N/A	Shared Landing?	N/A			
N/A	Gutter Ponding?	N/A	N/A	Gutter Slope (%)	N/A
N/A	Gutter Lip Ht (in)	N/A	N/A	Gutter X Slope (%)	N/A
N/A	Painted X Walk1?	No	N/A	Painted X Walk2?	N/A
	X Walk 1 Direction	To E		X Walk 2 Direction	N/A
N/A	X Walk 1 Width (in)	N/A	N/A	X Walk 2 Width (in)	N/A
	X Walk 1 Slope (%)	3.0		X Walk 2 Slope (%)	N/A
	X Walk 1 X Slope (%)	2.3		X Walk 2 X Slope (%)	N/A

N/A	Ramp inside XWalk1?	N/A	N/A	Ramp inside XWalk2?	N/A
	Road Slope (%)	N/A	N/A	Clear Space?	N/A
	Road X Slope (%)	N/A	N/A	Clear Space to XWalk (in)	N/A
N/A	Any Obstructions?	N/A	N/A	Storm Grate/Utility Hazard?	N/A
	Obstruction Type			Storm Grate/Utility Type	
		N/A			N/A
			Yes	Surface Condition? (G/P)	Good

Possible Solutions:

Remove & Replace Entire Ramp.

Total Cost: \$ 1850.00
