# Access Compliance Report

## Public Rights-of-Way

### (Curb Ramps)

Intersection ID: 54374	Main Street: GRIER_RD	Cross Street: OLD_CONCORD_RD	Location: NE
ADA ID: BED827697F70	Ramp Type: Perp	Initial Pass/Fail: Fail	Overall Compliance: No
			Severity Score: 21.25

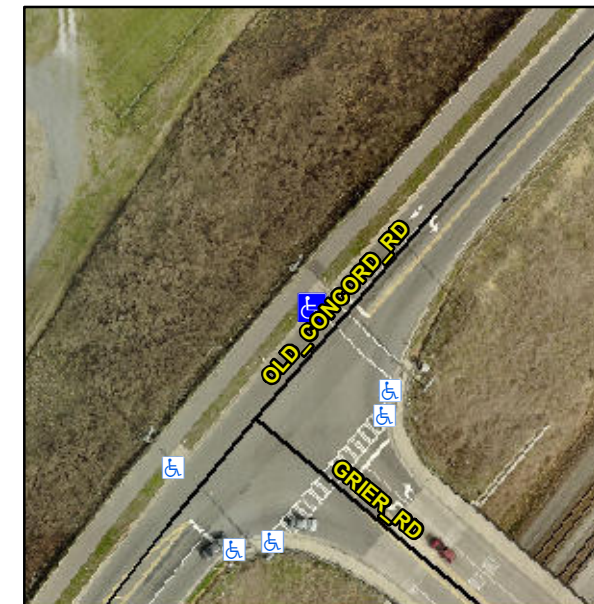
**Not Found, R304.5.1, R304.2.2**

Compliance	Description	Data	Compliance	Description	Data
N/A	Ramp Length (in)	79.0	No	Ramp Slope (%)	8.8
No	Ramp Width (in)	47.0	Yes	Ramp XSlope (%)	1.6
N/A	Flare Type LT	N/A	N/A	Flare Type RT	N/A
N/A	Flare Slope LT (%)	N/A	N/A	Flare Slope RT (%)	N/A
N/A	Flare Traversable LT?	N/A	N/A	Flare Traversable RT?	N/A
N/A	Landing Length (in)	N/A	N/A	DWS Provided?	N/A
N/A	Landing Width (in)	N/A	N/A	DWS Contrast?	N/A
N/A	Landing Slope (%)	N/A	N/A	DWS Length (in)	N/A
N/A	Landing X Slope (%)	N/A	N/A	DWS Full Width?	N/A
N/A	Landing Curb? (Y/N)	N/A	N/A	DWS Offset (in)	N/A
N/A	Shared Landing?	N/A			
N/A	Gutter Ponding?	N/A	N/A	Gutter Slope (%)	N/A
N/A	Gutter Lip Ht (in)	N/A	N/A	Gutter X Slope (%)	N/A
N/A	Painted X Walk1?	Yes	N/A	Painted X Walk2?	N/A
	X Walk 1 Direction	To SE		X Walk 2 Direction	N/A
N/A	X Walk 1 Width (in)	103.5	N/A	X Walk 2 Width (in)	N/A
	X Walk 1 Slope (%)	4.3		X Walk 2 Slope (%)	N/A
	X Walk 1 X Slope (%)	0.0		X Walk 2 X Slope (%)	N/A

N/A	Ramp inside XWalk1?	Yes	N/A	Ramp inside XWalk2?	N/A
	Road Slope (%)	N/A	N/A	Clear Space?	N/A
	Road X Slope (%)	N/A	N/A	Clear Space to XWalk (in)	N/A
N/A	Any Obstructions?	N/A	N/A	Storm Grate/Utility Hazard?	N/A
	Obstruction Type			Storm Grate/Utility Type	
		N/A			N/A
			Yes	Surface Condition? (G/P)	Good

**Remove & Replace Entire Ramp.**

Total Cost: \$ 1850.00
