Access Compliance Report Public Rights-of-Way (Curb Ramps)

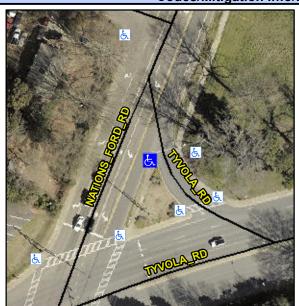
Intersection ID: 18844 Main Street: NATIONS_FORD_RD Cross Street: TYVOLA_RD Location: NE Ramp Type: IslandPerp **Overall Compliance: No** ADA ID: BED9F79FA481 Initial Pass/Fail: Fail **Severity Score:** 12.5

Field Measurements/Component Compliance								
Comp	liance Description	Data	Compli	ance	Description	Data		
N/A	Ramp Length (in)	48.0	No	Ramp	Slope (%)	10.1		
Yes	Ramp Width (in)	48.0	Yes	es Ramp XSlope (%)		1.9		
N/A	Flare Type LT	N/A	N/A	A Flare Type RT		N/A		
N/A	Flare Slope LT (%)	N/A	N/A	Flare	Slope RT (%)	N/A		
N/A	Flare Traversable LT?	N/A	N/A	Flare	Traversable RT?	N/A		
N/A	Landing Length (in)	N/A	N/A	DWS	Provided?	N/A		
N/A	Landing Width (in)	N/A	N/A	DWS	Contrast?	N/A		
N/A	Landing Slope (%)	N/A	N/A	DWS	Length (in)	N/A		
N/A	Landing X Slope (%)	N/A	N/A	DWS	Full Width?	N/A		
N/A	Landing Curb? (Y/N)	N/A	N/A	DWS	Offset (in)	N/A		
N/A	Shared Landing?	N/A						
N/A	Gutter Ponding?	N/A	N/A	Gutte	r Slope (%)	N/A		
N/A	Gutter Lip Ht (in)	N/A	N/A	Gutte	r X Slope (%)	N/A		
N/A	Painted X Walk1?	No	N/A	Painte	ed X Walk2?	N/A		
	X Walk 1 Direction	To E		X Wa	lk 2 Direction	N/A		
N/A	X Walk 1 Width (in)	N/A	N/A	X Wa	lk 2 Width (in)	N/A

X Walk 1 Slope (%)	1.8		X Wa	lk 2 Slope (%)	N/A		
	X Walk 1 X Slope (%)	2.4		X Wa	lk 2 X Slope (%)	N/A		
N/A	Ramp inside XWalk1?	N/A	N/A	Ramp	inside XWalk2?	N/A		
	Road Slope (%)	N/A	N/A	Clear	Space?	N/A		
	Road X Slope (%)	N/A	N/A	Clear	Space to XWalk (in)	N/A		
N/A	Any Obstructions?	N/A	N/A	Storm	Grate/Utility Hazard?	N/A		
	Obstruction Type			Storm	Grate/Utility Type			
		N/A				N/A		
			Yes	Surfa	ce Condition? (G/P)	Good		
Charles To

Possible Solutions:	Com
Remove & Replace Entire Ramp.	N/A
•	Yes
	N/A
	N/A
	N/A
	N/A
Surveyor Notes:	N/A
N/A	N/A
	N/A
	N/A
	N/A
PROW/ADA:	N/A
Not Found, R304.2.2	N/A
	N/A
	N/A
	N/A
