Access Compliance Report Public Rights-of-Way (Curb Ramps)

Intersection ID: 11481 Main Street: AFTON_LN Cross Street: THORNTON_RD Location: N

ADA ID: BEDB0E1BAFC7 Ramp Type: Perp Initial Pass/Fail: Fail Overall Compliance: No Severity Score: 12.5

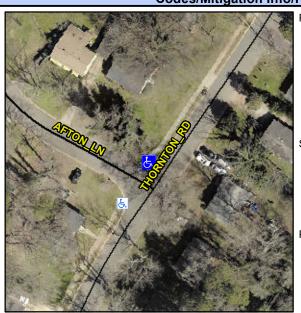
Not Found, R304.5.3

Fleid Measurements/Component Compilance						
Compliance Description			Data	Compliance Description		Data
1	N/A	Ramp Length (in)	48.0	Yes	Ramp Slope (%)	6.4
١	r es	Ramp Width (in)	48.0	No	Ramp XSlope (%)	6.1
N	N/A	Flare Type LT	N/A	N/A	Flare Type RT	N/A
1	N/A	Flare Slope LT (%)	N/A	N/A	Flare Slope RT (%)	N/A
1	N/A	Flare Traversable LT?	N/A	N/A	Flare Traversable RT?	N/A
1	N/A	Landing Length (in)	N/A	N/A	DWS Provided?	N/A
1	N/A	Landing Width (in)	N/A	N/A	DWS Contrast?	N/A
1	N/A	Landing Slope (%)	N/A	N/A	DWS Length (in)	N/A
1	N/A	Landing X Slope (%)	N/A	N/A	DWS Full Width?	N/A
1	N/A	Landing Curb? (Y/N)	N/A	N/A	DWS Offset (in)	N/A
ı	N/A	Shared Landing?	N/A			
ı	N/A	Gutter Ponding?	N/A	N/A	Gutter Slope (%)	N/A
N	N/A	Gutter Lip Ht (in)	N/A	N/A	Gutter X Slope (%)	N/A
ı	N/A	Painted X Walk1?	No	N/A	Painted X Walk2?	N/A
		X Walk 1 Direction	To SW		X Walk 2 Direction	N/A
1	N/A	X Walk 1 Width (in)	N/A	N/A	X Walk 2 Width (in)	N/A

X Walk 1 Slope (%)	5.2		X Walk 2 Slope (%)	N/A
		X Walk 1 X Slope (%)	1.4		X Walk 2 X Slope (%)	N/A
1	N/A	Ramp inside XWalk1?	N/A	N/A	Ramp inside XWalk2?	N/A
		Road Slope (%)	N/A	N/A	Clear Space?	N/A
		Road X Slope (%)	N/A	N/A	Clear Space to XWalk (in)	N/A
ı	N/A	Any Obstructions?	N/A	N/A	Storm Grate/Utility Hazard?	N/A
		Obstruction Type			Storm Grate/Utility Type	
			N/A			N/A
				Yes	Surface Condition? (G/P)	Good

Remove & Replace Entire Ramp.
