Access Compliance Report

Public Rights-of-Way

(Curb Ramps)

Intersection ID: 27900	Main Street: FROHOCK_PL	Cross Street: HARRISON'S_CROSSING_AV	Location: NE
ADA ID: BEE2D2FCAE56	Ramp Type: Perp	Initial Pass/Fail: Fail	Overall Compliance: No
Severity Score: 37.5			
Codes/Mitigation Info/Possible Solution		Field Measurements/Component Compliance

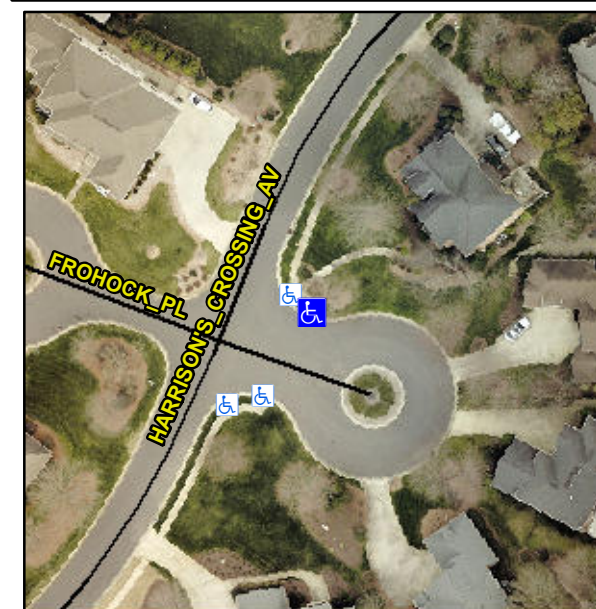
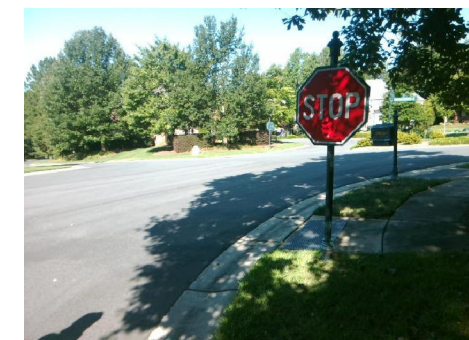
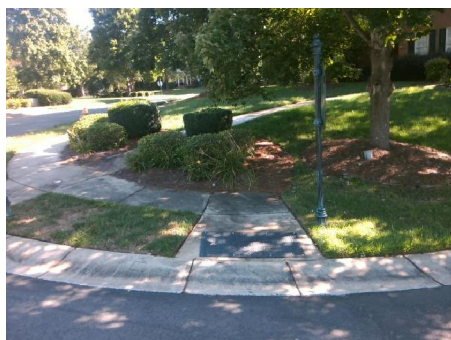
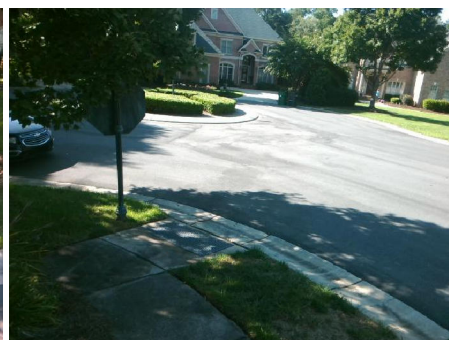
R304.2.2, R304.5.3

Compliance	Description	Data	Compliance	Description	Data
N/A	Ramp Length (in)	48.5	No	Ramp Slope (%)	10.8
Yes	Ramp Width (in)	48.0	No	Ramp XSlope (%)	10.2
N/A	Flare Type LT	N/A	N/A	Flare Type RT	N/A
N/A	Flare Slope LT (%)	N/A	N/A	Flare Slope RT (%)	N/A
N/A	Flare Traversable LT?	N/A	N/A	Flare Traversable RT?	N/A
N/A	Landing Length (in)	N/A	N/A	DWS Provided?	N/A
N/A	Landing Width (in)	N/A	N/A	DWS Contrast?	N/A
N/A	Landing Slope (%)	N/A	N/A	DWS Length (in)	N/A
N/A	Landing X Slope (%)	N/A	N/A	DWS Full Width?	N/A
N/A	Landing Curb? (Y/N)	N/A	N/A	DWS Offset (in)	N/A
N/A	Shared Landing?	N/A			
N/A	Gutter Ponding?	N/A	N/A	Gutter Slope (%)	N/A
N/A	Gutter Lip Ht (in)	N/A	N/A	Gutter X Slope (%)	N/A
N/A	Painted X Walk1?	No	N/A	Painted X Walk2?	N/A
	X Walk 1 Direction	To SW		X Walk 2 Direction	N/A
N/A	X Walk 1 Width (in)	N/A	N/A	X Walk 2 Width (in)	N/A
	X Walk 1 Slope (%)	1.0		X Walk 2 Slope (%)	N/A
	X Walk 1 X Slope (%)	7.3		X Walk 2 X Slope (%)	N/A

N/A	Ramp inside XWalk1?	N/A	N/A	Ramp inside XWalk2?	N/A
	Road Slope (%)	N/A	N/A	Clear Space?	N/A
	Road X Slope (%)	N/A	N/A	Clear Space to XWalk (in)	N/A
N/A	Any Obstructions?	N/A	N/A	Storm Grate/Utility Hazard?	N/A
	Obstruction Type			Storm Grate/Utility Type	
		N/A			N/A
			Yes	Surface Condition? (G/P)	Good

Remove & Replace Entire Ramp.

Total Cost: \$ 1850.00
