Access Compliance Report

Public Rights-of-Way

(Curb Ramps)

Intersection ID: 46306	Main Street: BECKET RIDGE RD	Cross Street: AUGUSTINE_WY	Location: NE
ADA ID: BEE76D8CE883	Ramp Type: Perp	Initial Pass/Fail: Fail	Overall Compliance: No
		Severity Score: 8.75

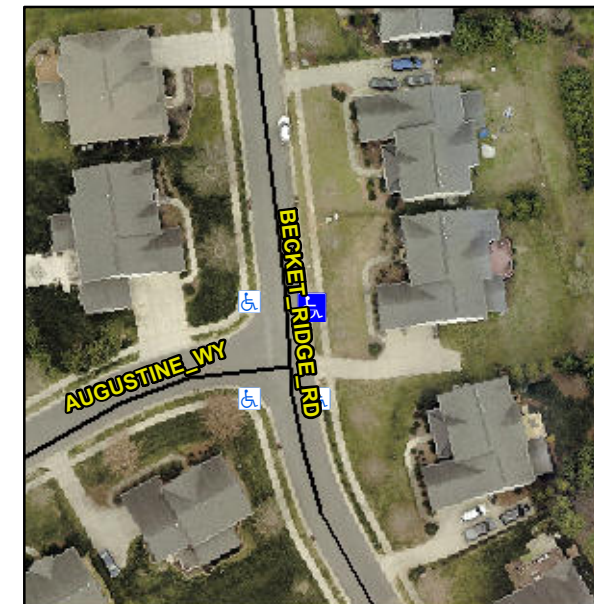
Not Found, R304.5.1

Compliance	Description	Data	Compliance	Description	Data
N/A	Ramp Length (in)	46.0	Yes	Ramp Slope (%)	6.5
No	Ramp Width (in)	47.5	Yes	Ramp XSlope (%)	1.0
N/A	Flare Type LT	N/A	N/A	Flare Type RT	N/A
N/A	Flare Slope LT (%)	N/A	N/A	Flare Slope RT (%)	N/A
N/A	Flare Traversable LT?	N/A	N/A	Flare Traversable RT?	N/A
N/A	Landing Length (in)	N/A	N/A	DWS Provided?	N/A
N/A	Landing Width (in)	N/A	N/A	DWS Contrast?	N/A
N/A	Landing Slope (%)	N/A	N/A	DWS Length (in)	N/A
N/A	Landing X Slope (%)	N/A	N/A	DWS Full Width?	N/A
N/A	Landing Curb? (Y/N)	N/A	N/A	DWS Offset (in)	N/A
N/A	Shared Landing?	N/A			
N/A	Gutter Ponding?	Yes	N/A	Gutter Slope (%)	N/A
N/A	Gutter Lip Ht (in)	N/A	N/A	Gutter X Slope (%)	N/A
N/A	Painted X Walk1?	No	N/A	Painted X Walk2?	N/A
	X Walk 1 Direction	To W		X Walk 2 Direction	N/A
N/A	X Walk 1 Width (in)	N/A	N/A	X Walk 2 Width (in)	N/A
	X Walk 1 Slope (%)	1.3		X Walk 2 Slope (%)	N/A
	X Walk 1 X Slope (%)	1.4		X Walk 2 X Slope (%)	N/A

N/A	Ramp inside XWalk1?	N/A	N/A	Ramp inside XWalk2?	N/A
	Road Slope (%)	N/A	N/A	Clear Space?	N/A
	Road X Slope (%)	N/A	N/A	Clear Space to XWalk (in)	N/A
N/A	Any Obstructions?	N/A	N/A	Storm Grate/Utility Hazard?	N/A
	Obstruction Type			Storm Grate/Utility Type	
		N/A			N/A
		Yes		Surface Condition? (G/P)	Good

Possible Solutions:

Remove & Replace Entire Ramp.

Total Cost: \$ 1850.00
