Access Compliance Report

Public Rights-of-Way (Curb Ramps)

Intersection ID: 10018432	Main Street: WITHAM PASSAGE	Cross Street: N/A	Location:	N
ADA ID: BEE785938FCA	Ramp Type: Directional1	Initial Pass/Fail: Fail	Overall Compliance: No	Severity Score: 22.5

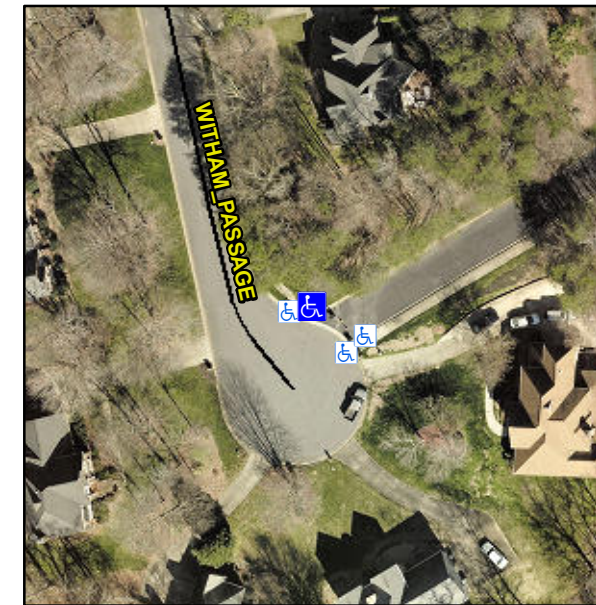
R304.5.1, R304.2.2

Compliance	Description	Data	Compliance	Description	Data
N/A	Ramp Length (in)	60.0	N/A	Grade Break?	N/A
No	Ramp Width (in)	47.5	N/A	Grade Break Slope (%)	0.0
No	Ramp Slope (%)	11.9	N/A	Grade Break XSlope (%)	0.0
Yes	Ramp XSlope (%)	2.5			
N/A	Flare Type LT	N/A	N/A	Flare Type RT	N/A
N/A	Flare Slope LT (%)	N/A	N/A	Flare Slope RT (%)	0.0
N/A	Flare Traversable LT?	N/A	N/A	Flare Traversable RT?	N/A
N/A	Landing Length (in)	0.0	N/A	DWS Provided?	N/A
N/A	Landing Width (in)	0.0	N/A	DWS Contrast?	N/A
N/A	Landing Slope (%)	0.0	N/A	DWS Length (in)	N/A
N/A	Landing X Slope (%)	0.0	N/A	DWS Full Width?	N/A
N/A	Landing Curb? (Y/N)	N/A	N/A	DWS Offset LT (in)	N/A
N/A	Shared Landing?	N/A	N/A	DWS Offset RT (in)	N/A
N/A	Gutter Ponding?	0.0	N/A	Gutter Slope (%)	N/A
N/A	Gutter Lip Ht (in)	0.0	N/A	Gutter X Slope (%)	N/A
N/A	Painted X Walk1?	No		Road Slope (%)	6.8
	X Walk 1 Direction	To SE		Road X Slope (%)	10.0
	X Walk 1 Width (in)	N/A		Clear Space?	N/A

X Walk 1 Slope (%)	6.8	N/A	Clear Space to XWalk (in)	N/A
	X Walk 1 X Slope (%)	10.0	N/A	Storm Grate/Utility Hazard?	N/A
N/A	Ramp inside XWalk1?	N/A		Storm Grate/Utility Type	
N/A	Any Obstructions?	N/A			N/A
	Obstruction Type		Yes	Surface Condition? (G/P)	Good
			N/A	Curb Slope (%)	22.1

Remove & Replace Entire Ramp.
