# Access Compliance Report

## Public Rights-of-Way (Curb Ramps)

Intersection ID: 51379	Main Street: BROADRICK_BV	Cross Street: UNIVERSITY_CITY_BV	Location:	S
ADA ID: BEF3E8F820AA	Ramp Type: Directional1	Initial Pass/Fail: Pass	Overall Compliance: No	Severity Score: 0

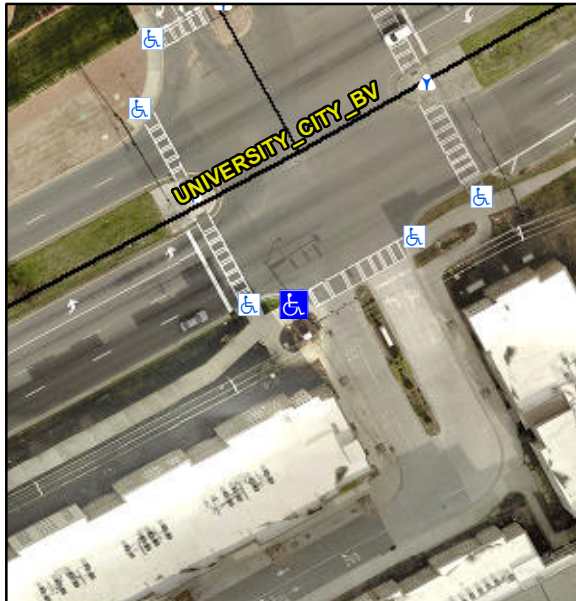
Compliance	Description	Data	Compliance	Description	Data
N/A	Ramp Length (in)	101.0	N/A	Grade Break?	N/A
Yes	Ramp Width (in)	117.5	N/A	Grade Break Slope (%)	2.5
Yes	Ramp Slope (%)	1.4	N/A	Grade Break XSlope (%)	0.5
Yes	Ramp XSlope (%)	0.9			
Yes	Flare Type LT	N/A	Yes	Flare Type RT	N/A
N/A	Flare Slope LT (%)	N/A	N/A	Flare Slope RT (%)	N/A
N/A	Flare Traversable LT?	No	N/A	Flare Traversable RT?	No
Yes	Landing Length (in)	99.0	Yes	DWS Provided?	Yes
Yes	Landing Width (in)	118.0	Yes	DWS Contrast?	Yes
No	Landing Slope (%)	2.8	Yes	DWS Length (in)	24.0
No	Landing X Slope (%)	2.5	Yes	DWS Full Width?	Yes
N/A	Landing Curb? (Y/N)	No	Yes	DWS Offset LT (in)	54.0
N/A	Shared Landing?	No	Yes	DWS Offset RT (in)	0.0
Yes	Gutter Ponding?	No	Yes	Gutter Slope (%)	2.0
Yes	Gutter Lip Ht (in)	0.0	No	Gutter X Slope (%)	2.5
N/A	Painted X Walk1?	Yes		Road Slope (%)	2.1
	X Walk 1 Direction	To NE		Road X Slope (%)	1.3
	X Walk 1 Width (in)	106.0		Clear Space?	Yes

X Walk 1 Slope (%)	2.1	N/A	Clear Space to XWalk (in)	N/A
	X Walk 1 X Slope (%)	1.3	Yes	Storm Grate/Utility Hazard?	No
Yes	Ramp inside XWalk1?	Yes		Storm Grate/Utility Type	
Yes	Any Obstructions?	No			N/A
	Obstruction Type		Yes	Surface Condition? (G/P)	Good
			N/A	Curb Slope (%)	2.5

Possible Solutions:

**Remove & Replace Landing.  
Remove & Replace Gutter.**
