Access Compliance Report Public Rights-of-Way (Curb Ramps)

Intersection ID: 10040568 Main Street: W ARROWOOD RD **Cross Street: N/A** Location: SE ADA ID: BEF45BD982A3 Ramp Type: PerpDiag Initial Pass/Fail: Fail **Overall Compliance: No Severity Score:** 12.5

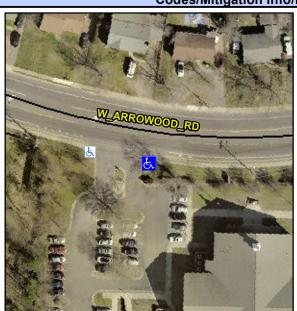
Field Measurements/Component Compliance							
	Compl	iance Description	Data	Comp	liance I	Description	Data
	N/A	Ramp Length (in)	61.0	No	Ramp	Slope (%)	9.0
	Yes	Ramp Width (in)	48.0	Yes	Ramp 2	XSlope (%)	1.8
	N/A	Flare Type LT	N/A	N/A	Flare T	ype RT	N/A
	N/A	Flare Slope LT (%)	N/A	N/A	Flare S	Slope RT (%)	N/A
	N/A	Flare Traversable LT?	N/A	N/A	Flare T	raversable RT?	N/A
	N/A	Landing Length (in)	N/A	N/A	DWS F	Provided?	N/A
	N/A	Landing Width (in)	N/A	N/A	DWS C	Contrast?	N/A
	N/A	Landing Slope (%)	N/A	N/A	DWS L	ength (in)	N/A
	N/A	Landing X Slope (%)	N/A	N/A	DWS F	Full Width?	N/A
	N/A	Landing Curb? (Y/N)	N/A	N/A	DWS C	Offset (in)	N/A
	N/A	Shared Landing?	N/A				
	N/A	Gutter Ponding?	N/A	N/A	Gutter	Slope (%)	N/A
	N/A	Gutter Lip Ht (in)	N/A	N/A	Gutter	X Slope (%)	N/A
	N/A	Painted X Walk1?	No	N/A	Painted	d X Walk2?	No
		X Walk 1 Direction	To N		X Walk	2 Direction	To W
	N/A	X Walk 1 Width (in)	N/A	N/A	X Walk	2 Width (in)	N/A

X Walk 1 Slope (%)	3.3		X Walk	(2 Slope (%)	5.3
		X Walk 1 X Slope (%)	1.7		X Walk	(2 X Slope (%)	0.1
	N/A	Ramp inside XWalk1?	N/A	N/A	Ramp i	inside XWalk2?	N/A
		Road Slope (%)	1.9	N/A	Clear S	Space?	N/A
		Road X Slope (%)	4.2	N/A	Clear S	Space to XWalk (in)	N/A
	N/A	Any Obstructions?	N/A	N/A	Storm	Grate/Utility Hazard?	N/A
		Obstruction Type			Storm	Grate/Utility Type	
			N/A				N/A
				Yes	Surface	e Condition? (G/P)	Good
8	The second	as the same

W ARROWOOD RD Street 1 Name Stop Condition-Street 2 None Street 2 Name **ENTRANCE** Stop Condition-Street 1 None Possible Solutions: Remove & Replace Curb Ramp With Two New Directional Ramps or Equivalent. Surveyor Notes: N/A PROW/ADA: Not Found, R304.2.2
