## **Access Compliance Report Public Rights-of-Way** (Curb Ramps)

Intersection ID: 18832 Main Street: SENECA PL Cross Street: VALLEY\_STREAM\_RD Location: SW **ADA ID: BEF4C2ED90EE** Ramp Type: ParaDiag Initial Pass/Fail: Fail **Overall Compliance: No** Severity Score: 13.75

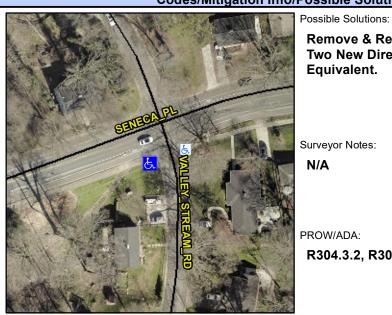
R304.3.2, R304.5.3

Comp	liance Description	Data	Comp	liance Description	Data
N/A	Ramp Length LT (in)	36.0	N/A	Ramp Length RT (in)	55.0
Yes	Ramp Width LT (in)	77.0	Yes	Ramp Width RT (in)	74.0
No	Ramp Slope LT (%)	10.9	Yes	Ramp Slope RT (%)	6.2
No	Ramp XSlope LT (%)	4.3	No	Ramp XSlope RT (%)	4.2
N/A	Landing Length (in)	N/A	N/A	DWS Provided?	N/A
N/A	Landing Width (in)	N/A	N/A	DWS Contrast?	N/A
N/A	Landing Slope (%)	N/A	N/A	DWS Length (in)	N/A
N/A	Landing X Slope (%)	N/A	N/A	DWS Full Width?	N/A
N/A	Landing Curb? (Y/N)	N/A	N/A	DWS Offset (in)	N/A
N/A	Shared Landing?	N/A			
N/A	Gutter Ponding?	N/A	N/A	Gutter Slope (%)	N/A
N/A	Gutter Lip Ht (in)	N/A	N/A	Gutter X Slope (%)	N/A
N/A	Painted X Walk1?	No	N/A	Painted X Walk2?	No
	X Walk 1 Direction	To E		X Walk 2 Direction	To N
N/A	X Walk 1 Width (in)	N/A	N/A	X Walk 2 Width (in)	N/A
	X Walk 1 Slope (%)	13.5		X Walk 2 Slope (%)	4.2
	X Walk 1 X Slope (%)	0.4		X Walk 2 X Slope (%)	13.3
N/A	Ramp inside XWalk1?	N/A	N/A	Ramp inside XWalk2?	N/A

Road Slope (%)	7.3	N/A	Clear Space?	N/A
	Road X Slope (%)	12.3	N/A	Clear Space to XWalk (in)	N/A
N/A	Any Obstructions?	N/A	N/A	Storm Grate/Utility Hazard?	N/A
	Obstruction Type			Storm Grate/Utility Type	
		N/A			N/A
			Yes	Surface Condition? (G/P)	Good
			N/A	Curb Slope (%)	13.9

Remove & Replace Curb Ramp With Two New Directional Ramps or Equivalent.
