# Access Compliance Report

## Public Rights-of-Way

### (Curb Ramps)

Intersection ID: 15368		Main Street: KENILWORTH_AV		Cross Street: LATTIMORE_ST		Location: S							
ADA ID: BEF56BF3BF4F		Ramp Type: Directional2		Initial Pass/Fail: Fail		Overall Compliance: No		Severity Score: 25					
Codes/Mitigation Info/Possible Solution				Field Measurements/Component Compliance									
<div>

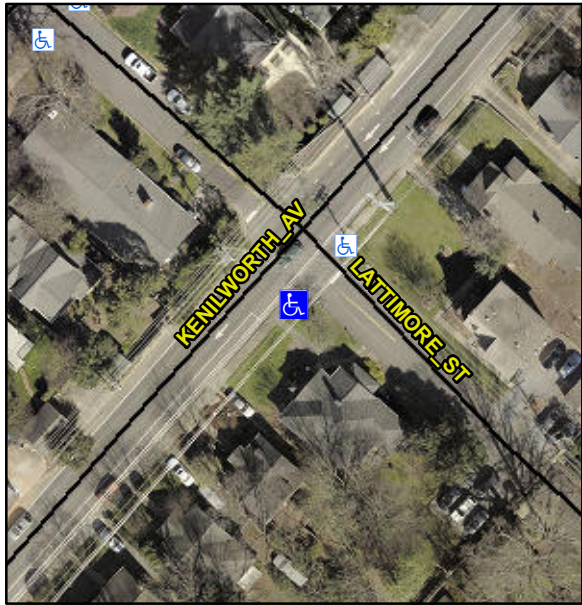
</div> <div>Possible Solutions: <b>Remove &amp; Replace Entire Ramp.</b></div> <div>Surveyor Notes: <b>N/A</b></div> <div>PROW/ADA: <b>R304.5.3</b></div> <div><div>Street 1 NameLATTIMORE_ST</div><div>Stop Condition-Street 1StopSign</div><div>Street 2 NameN/A</div><div>Stop Condition-Street 2N/A</div></div>				Compliance	Description	Data	Compliance	Description	Data				
				N/A	Ramp Length (in)	53.0	N/A	Grade Break?	N/A				
				Yes	Ramp Width (in)	60.0	N/A	Grade Break Slope (%)	0.0				
				Yes	Ramp Slope (%)	5.6	N/A	Grade Break XSlope (%)	0.0				
				No	Ramp XSlope (%)	8.5							
				N/A	Flare Type LT	N/A	N/A	Flare Type RT	N/A

N/A	Flare Slope LT (%)	N/A	N/A	Flare Slope RT (%)	0.0				
				N/A	Flare Traversable LT?	N/A	N/A	Flare Traversable RT?	N/A				
				N/A	Landing Length (in)	0.0	N/A	DWS Provided?	N/A				
				N/A	Landing Width (in)	0.0	N/A	DWS Contrast?	N/A				
				N/A	Landing Slope (%)	0.0	N/A	DWS Length (in)	N/A				
				N/A	Landing X Slope (%)	0.0	N/A	DWS Full Width?	N/A				
				N/A	Landing Curb? (Y/N)	N/A	N/A	DWS Offset LT (in)	N/A				
				N/A	Shared Landing?	N/A	N/A	DWS Offset RT (in)	N/A				
				N/A	Gutter Ponding?	0.0	N/A	Gutter Slope (%)	N/A				
				N/A	Gutter Lip Ht (in)	0.0	N/A	Gutter X Slope (%)	N/A				
				N/A	Painted X Walk1?	No		Road Slope (%)	1.0				
					X Walk 1 Direction	To NE		Road X Slope (%)	0.0				
					X Walk 1 Width (in)	N/A		Clear Space?	N/A				
					X Walk 1 Slope (%)	1.0	N/A	Clear Space to XWalk (in)	N/A				
					X Walk 1 X Slope (%)	0.0	N/A	Storm Grate/Utility Hazard?	N/A				
				N/A	Ramp inside XWalk1?	N/A		Storm Grate/Utility Type

N/A	Any Obstructions?	N/A			N/A				
					Obstruction Type		Yes	Surface Condition? (G/P)	Good				
							N/A	Curb Slope (%)	16.4				
				Total Cost:				\$	1800.00
