Access Compliance Report

Public Rights-of-Way

(Curb Ramps)

Intersection ID: 10038358		Main Street: SOUTH_BV		Cross Street: N/A		Location: NE											
ADA ID: BEF786928716		Ramp Type: Directional1		Initial Pass/Fail: Fail		Overall Compliance: No		Severity Score: 12.5									
Codes/Mitigation Info/Possible Solution				Field Measurements/Component Compliance													
<div>

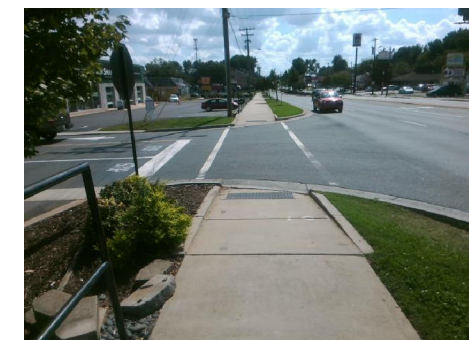
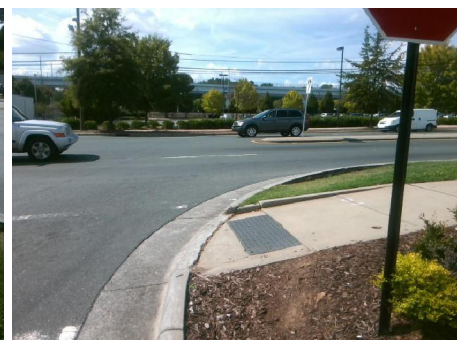
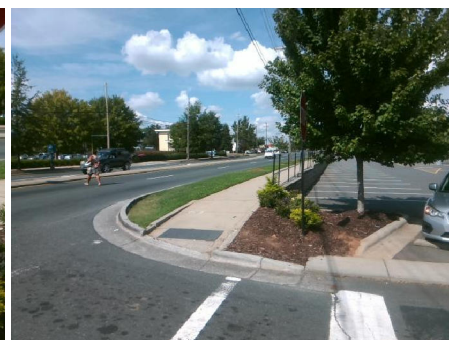
X Walk 1 X Slope (%)		6.1		N/A		Storm Grate/Utility Hazard?		N/A			
				N/A		Ramp inside XWalk1?		Yes				Storm Grate/Utility Type					
				N/A		Any Obstructions?		N/A						N/A			
						Obstruction Type				Yes		Surface Condition? (G/P)		Good			
										N/A		N/A		Curb Slope (%)		7.0
