# Access Compliance Report

## Public Rights-of-Way

### (Curb Ramps)

Intersection ID: 11025	Main Street: CAMP_GREENE_ST	Cross Street: ELON_ST	Location: SE
ADA ID: BF0C86FD2DB4	Ramp Type: PerpDiag	Initial Pass/Fail: Fail	Overall Compliance: No
		Severity Score: 12.5

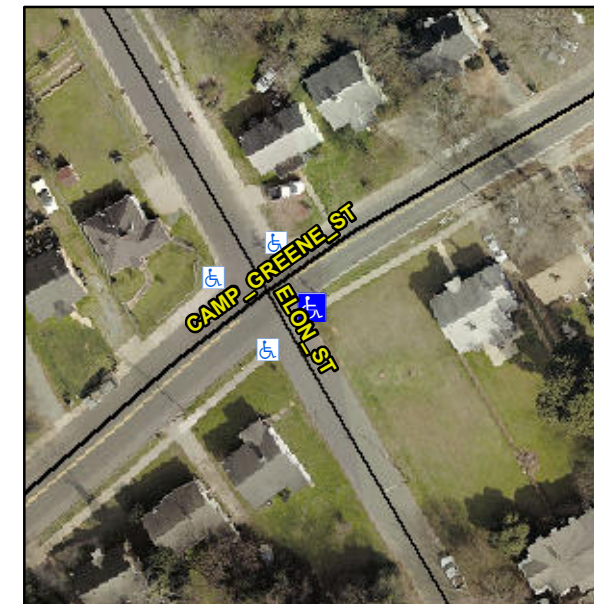
Compliance	Description	Data	Compliance	Description	Data
N/A	Ramp Length (in)	38.0	No	Ramp Slope (%)	10.0
Yes	Ramp Width (in)	85.0	Yes	Ramp XSlope (%)	1.6
N/A	Flare Type LT	N/A	N/A	Flare Type RT	N/A
N/A	Flare Slope LT (%)	N/A	N/A	Flare Slope RT (%)	N/A
N/A	Flare Traversable LT?	N/A	N/A	Flare Traversable RT?	N/A
N/A	Landing Length (in)	N/A	N/A	DWS Provided?	N/A
N/A	Landing Width (in)	N/A	N/A	DWS Contrast?	N/A
N/A	Landing Slope (%)	N/A	N/A	DWS Length (in)	N/A
N/A	Landing X Slope (%)	N/A	N/A	DWS Full Width?	N/A
N/A	Landing Curb? (Y/N)	N/A	N/A	DWS Offset (in)	N/A
N/A	Shared Landing?	N/A			
N/A	Gutter Ponding?	N/A	N/A	Gutter Slope (%)	N/A
N/A	Gutter Lip Ht (in)	N/A	N/A	Gutter X Slope (%)	N/A
N/A	Painted X Walk1?	No	N/A	Painted X Walk2?	No
	X Walk 1 Direction	To N		X Walk 2 Direction	To W
N/A	X Walk 1 Width (in)	N/A	N/A	X Walk 2 Width (in)	N/A
	X Walk 1 Slope (%)	2.8		X Walk 2 Slope (%)	1.6
	X Walk 1 X Slope (%)	4.7		X Walk 2 X Slope (%)	2.7

N/A	Ramp inside XWalk1?	N/A	N/A	Ramp inside XWalk2?	N/A
	Road Slope (%)	0.2	N/A	Clear Space?	N/A
	Road X Slope (%)	2.5	N/A	Clear Space to XWalk (in)	N/A
N/A	Any Obstructions?	N/A	N/A	Storm Grate/Utility Hazard?	N/A
	Obstruction Type			Storm Grate/Utility Type	
		N/A			N/A
		Yes		Surface Condition? (G/P)	Good

**Remove & Replace Curb Ramp With Two New Directional Ramps or Equivalent.**

**R304.2.2**
