Access Compliance Report

Public Rights-of-Way

(Curb Ramps)

Intersection ID: 13010	Main Street: HICKORY GROVE RD	Cross Street: DOGWOOD PL	Location: NE
ADA ID: BF179E1BF5D3	Ramp Type: PerpDiag	Initial Pass/Fail: Fail	Overall Compliance: No
Severity Score: 21.25			
Codes/Mitigation Info/Possible Solution		Field Measurements/Component Compliance

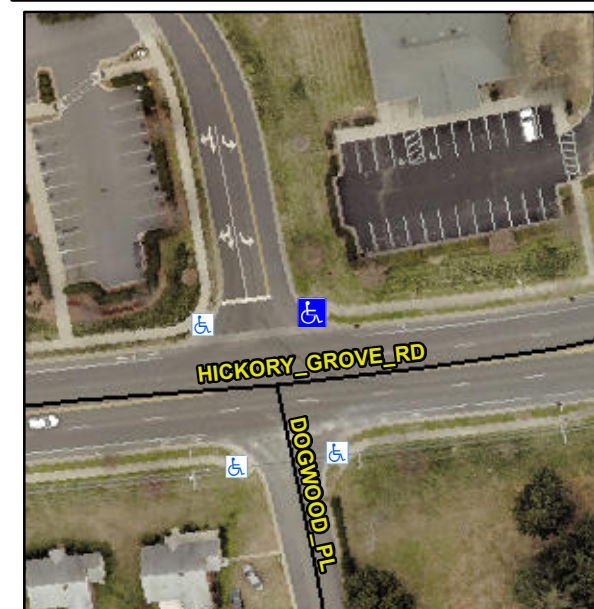
Not Found, R304.5.1, R304.2.2

Compliance	Description	Data	Compliance	Description	Data
N/A	Ramp Length (in)	48.0	No	Ramp Slope (%)	10.0
No	Ramp Width (in)	45.0	Yes	Ramp XSlope (%)	1.7
N/A	Flare Type LT	N/A	N/A	Flare Type RT	N/A
N/A	Flare Slope LT (%)	N/A	N/A	Flare Slope RT (%)	N/A
N/A	Flare Traversable LT?	N/A	N/A	Flare Traversable RT?	N/A
N/A	Landing Length (in)	N/A	N/A	DWS Provided?	N/A
N/A	Landing Width (in)	N/A	N/A	DWS Contrast?	N/A
N/A	Landing Slope (%)	N/A	N/A	DWS Length (in)	N/A
N/A	Landing X Slope (%)	N/A	N/A	DWS Full Width?	N/A
N/A	Landing Curb? (Y/N)	N/A	N/A	DWS Offset (in)	N/A
N/A	Shared Landing?	N/A			
N/A	Gutter Ponding?	N/A	N/A	Gutter Slope (%)	N/A
N/A	Gutter Lip Ht (in)	N/A	N/A	Gutter X Slope (%)	N/A
N/A	Painted X Walk1?	No	N/A	Painted X Walk2?	No
	X Walk 1 Direction	To W		X Walk 2 Direction	To S
N/A	X Walk 1 Width (in)	N/A	N/A	X Walk 2 Width (in)	N/A
	X Walk 1 Slope (%)	2.3		X Walk 2 Slope (%)	4.3
	X Walk 1 X Slope (%)	1.2		X Walk 2 X Slope (%)	0.5

N/A	Ramp inside XWalk1?	N/A	N/A	Ramp inside XWalk2?	N/A
	Road Slope (%)	0.9	N/A	Clear Space?	N/A
	Road X Slope (%)	3.4	N/A	Clear Space to XWalk (in)	N/A
N/A	Any Obstructions?	N/A	N/A	Storm Grate/Utility Hazard?	N/A
	Obstruction Type			Storm Grate/Utility Type	
		N/A			N/A
			Yes	Surface Condition? (G/P)	Good

Possible Solutions:

Remove & Replace Curb Ramp With Two New Directional Ramps or Equivalent.
