Access Compliance Report Public Rights-of-Way (Curb Ramps)

Intersection ID: 29226Main Street:KORNIV_DRCross Street:ROZUMNY_DRLocation:NWADA ID: BF536CE15D63Ramp Type:PerpDiagInitial Pass/Fail:FailOverall Compliance:NoSeverity Score:12.5

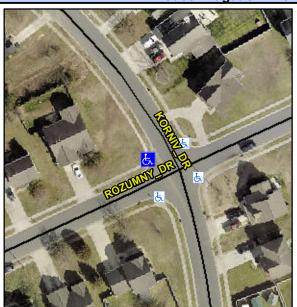
Not Found, R304.5.3

| Field Measurements/Component Compliance | | | | | |
|---|---|---|---|---|---|
| Yes | Ramp Width (in) | 54.0 | No | Ramp XSlope (%) | 6.3 |

Remove & Replace Curb Ramp With
Two New Directional Ramps or
Equivalent.
