Access Compliance Report

Public Rights-of-Way

(Curb Ramps)

| Intersection ID: 2746 | Main Street: BELL'S_MILL_DR | Cross Street: TANAGER_LN | Location: E |

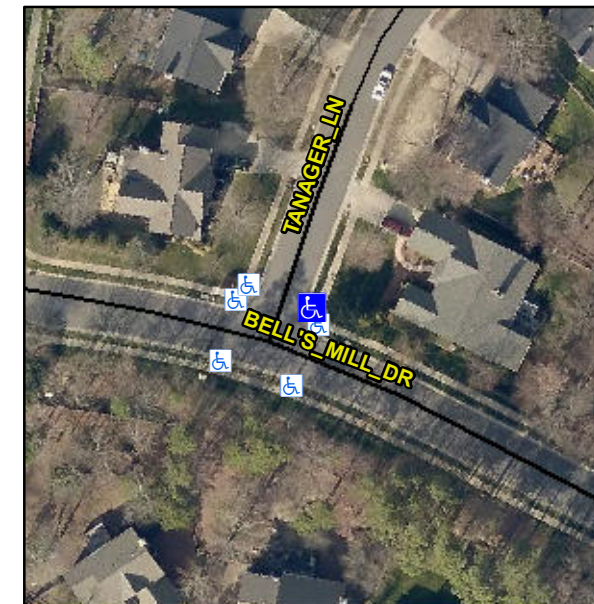
| ADA ID: BF561393E1E3 | Ramp Type: Perp | Initial Pass/Fail: Fail | Overall Compliance: No |
| | | Severity Score: 35 | |

R304.5.1, R304.2.2, R304.5.3

| Compliance | Description | Data | Compliance | Description | Data |
|---|---|---|---|---|---|
| N/A | Ramp Length (in) | 48.0 | No | Ramp Slope (%) | 15.0 |
| No | Ramp Width (in) | 40.0 | No | Ramp XSlope (%) | 4.0 |

Possible Solutions:

Remove & Replace Entire Ramp.
