# Access Compliance Report

## Public Rights-of-Way

### (Curb Ramps)

Intersection ID: 12475	Main Street: AIRPORT_CENTER_PY	Cross Street: GOLF_ACRES_DR	Location: NW
ADA ID: BF597E8DF794	Ramp Type: PerpDiag	Initial Pass/Fail: Fail	Overall Compliance: No
Codes/Mitigation Info/Possible Solution		Field Measurements/Component Compliance	
Severity Score: 46.25

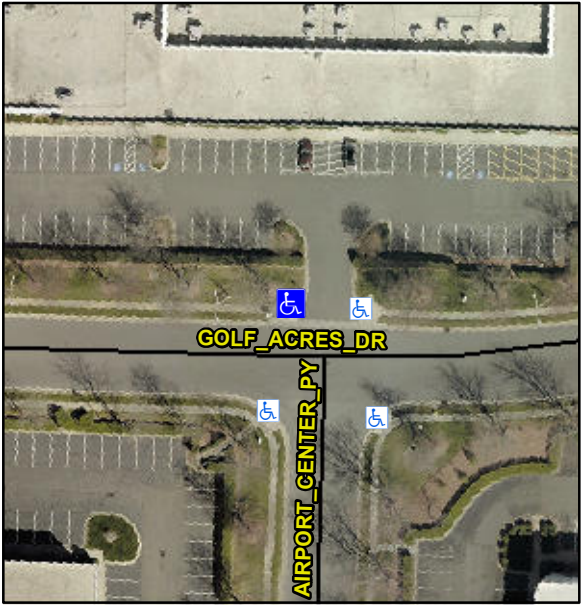
Compliance	Description	Data	Compliance	Description	Data
N/A	Ramp Length (in)	104.0	No	Ramp Slope (%)	9.0
No	Ramp Width (in)	38.0	No	Ramp XSlope (%)	14.9
N/A	Flare Type LT	N/A	N/A	Flare Type RT	N/A
N/A	Flare Slope LT (%)	N/A	N/A	Flare Slope RT (%)	N/A
N/A	Flare Traversable LT?	N/A	N/A	Flare Traversable RT?	N/A
N/A	Landing Length (in)	N/A	N/A	DWS Provided?	N/A
N/A	Landing Width (in)	N/A	N/A	DWS Contrast?	N/A
N/A	Landing Slope (%)	N/A	N/A	DWS Length (in)	N/A
N/A	Landing X Slope (%)	N/A	N/A	DWS Full Width?	N/A
N/A	Landing Curb? (Y/N)	N/A	N/A	DWS Offset (in)	N/A
N/A	Shared Landing?	N/A			
N/A	Gutter Ponding?	N/A	N/A	Gutter Slope (%)	N/A
N/A	Gutter Lip Ht (in)	N/A	N/A	Gutter X Slope (%)	N/A
N/A	Painted X Walk1?	No	N/A	Painted X Walk2?	No
	X Walk 1 Direction	To S		X Walk 2 Direction	To E
N/A	X Walk 1 Width (in)	N/A	N/A	X Walk 2 Width (in)	N/A
	X Walk 1 Slope (%)	4.0		X Walk 2 Slope (%)	0.6
	X Walk 1 X Slope (%)	2.1		X Walk 2 X Slope (%)	11.6

N/A	Ramp inside XWalk1?	N/A	N/A	Ramp inside XWalk2?	N/A
	Road Slope (%)	12.1	N/A	Clear Space?	N/A
	Road X Slope (%)	9.0	N/A	Clear Space to XWalk (in)	N/A
N/A	Any Obstructions?	N/A	N/A	Storm Grate/Utility Hazard?	N/A
	Obstruction Type			Storm Grate/Utility Type	
		N/A			N/A
			Yes	Surface Condition? (G/P)	Good

Possible Solutions:				
	Remove & Replace Curb Ramp With Two New Directional Ramps or Equivalent.				
	Surveyor Notes:				
	N/A				
	PROW/ADA:				
	R304.5.1, R304.2.2, R304.5.3				
Street 1 Name	GOLF ACRES DR				
Stop Condition-Street 2	None				
Street 2 Name	AIRPORT CENTER PY				
Stop Condition-Street 1	StopSign				
Total Cost:		\$	3200.00
