Access Compliance Report

Public Rights-of-Way

(Curb Ramps)

Intersection ID: N/A	Main Street: WILTHSHIRE_MANOR_DR	Cross Street: HATTON_CROSS_DR	Location: NW
ADA ID: BF5A9768204D	Ramp Type: Directional1	Initial Pass/Fail: Fail	Overall Compliance: No
Codes/Mitigation Info/Possible Solution		Field Measurements/Component Compliance	
Severity Score: 10

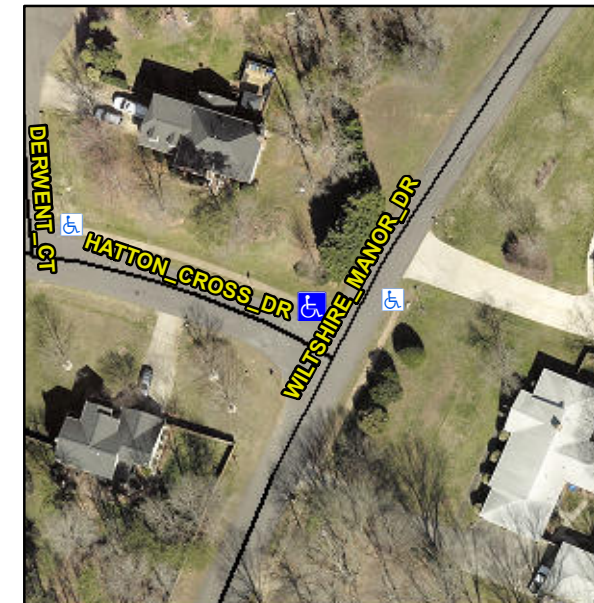
Compliance	Description	Data	Compliance	Description	Data
N/A	Ramp Length (in)	38.5	N/A	Grade Break?	N/A
No	Ramp Width (in)	47.0	N/A	Grade Break Slope (%)	0.0
Yes	Ramp Slope (%)	3.2	N/A	Grade Break XSlope (%)	0.0
No	Ramp XSlope (%)	2.5			
N/A	Flare Type LT	N/A	N/A	Flare Type RT	N/A
N/A	Flare Slope LT (%)	N/A	N/A	Flare Slope RT (%)	0.0
N/A	Flare Traversable LT?	N/A	N/A	Flare Traversable RT?	N/A
N/A	Landing Length (in)	0.0	N/A	DWS Provided?	N/A
N/A	Landing Width (in)	0.0	N/A	DWS Contrast?	N/A
N/A	Landing Slope (%)	0.0	N/A	DWS Length (in)	N/A
N/A	Landing X Slope (%)	0.0	N/A	DWS Full Width?	N/A
N/A	Landing Curb? (Y/N)	N/A	N/A	DWS Offset LT (in)	N/A
N/A	Shared Landing?	N/A	N/A	DWS Offset RT (in)	N/A
N/A	Gutter Ponding?	0.0	N/A	Gutter Slope (%)	N/A
N/A	Gutter Lip Ht (in)	0.0	N/A	Gutter X Slope (%)	N/A
N/A	Painted X Walk1?	No		Road Slope (%)	4.7
	X Walk 1 Direction	To E		Road X Slope (%)	1.3
	X Walk 1 Width (in)	N/A		Clear Space?	N/A

X Walk 1 Slope (%)	4.7	N/A	Clear Space to XWalk (in)	N/A
	X Walk 1 X Slope (%)	1.3	N/A	Storm Grate/Utility Hazard?	N/A
N/A	Ramp inside XWalk1?	N/A		Storm Grate/Utility Type	
N/A	Any Obstructions?	N/A			N/A
	Obstruction Type		Yes	Surface Condition? (G/P)	Good
			N/A	Curb Slope (%)	8.0

Possible Solutions:

Remove & Replace Entire Ramp.

R304.5.1, R304.5.3
